DDAS Accident Report

Report date: 05/03/2011	Accident number: 625
Accident time: 09:11	Accident Date: 07/04/2010
Where it occurred: MF 477, Jabir1, Jabir Village, Mafraq Province	Country: Jordan
Primary cause: Field control inadequacy (?)	Secondary cause: Unavoidable (?)
Class: Excavation accident	Date of main report: Not recorded
ID original source: None	Name of source: Demining group
Organisation: [Name removed]	
Mine/device: M14 AP blast	Ground condition: grass/grazing area hard rocks/stones
Date record created:	Date last modified: 05/03/2011
No of victims: 1	No of documents: 2

INCIDENT INVESTIGATION FOR [Demining group] – MINE ACTION TEAM - JORDAN

TASK NAME: JABIR 1 (477), NORTH BORDER PROJECT. EAST SECTOR

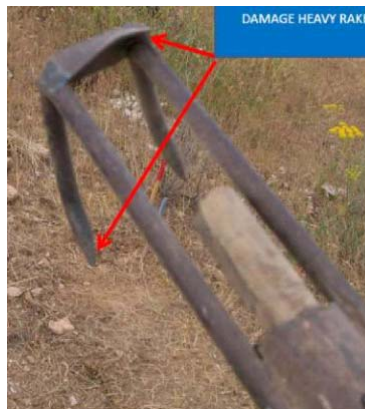
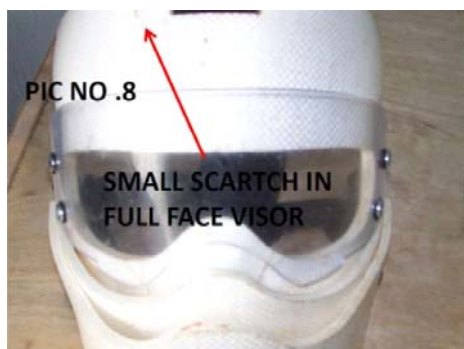
1. The deminer didn't use the light rake.
2. He didn't make the visual check because there were stones in the clearance box.
3. The deminer checked the signal out of the box and it was 70 cm from the base stick.
4. The base stick is in the right place.

5. He didn't do the right procedures in cutting grass and removing loose stones according to the SOP.
6. The area is hard with lots of stones which mean to be careful in using the heavy rake.
7. The depth of crater is 18 cm and the mine was on 13 cm depth.
8. He started progressing from the right side then he took it from the front which is wrong and caused a mine blast.
9. The heavy rake has been damaged because of the blast.
10. The marking sticks are put in the right place according to SOP.

1. The Deminer didn't follow the right drill before searching the mine.(visual check and clearing the loose stones in the clearance box).
2. The area is grassy and hard hence light rake is not effective.
3. He shouldn't check beyond 50 cm from the base stick (one clearance box) but he extended the search up to 70cm.
4. The mine blast incident occurred due to the individual mistake of doing wrong drills.

It is strongly recommended to issue a written warning to the deminer for not following the right procedure and drill which resulted in the mine blast incident.
