DDASaccident628

DDAS Accident Report

INCIDENT INVESTIGATION [Demining group] – MINE ACTION TEAM - JORDAN

TASK NAME AL SHAJARAH 1 (387)

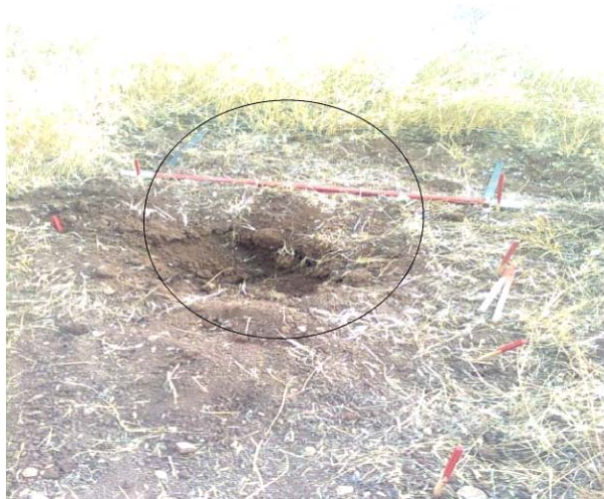
Deminer was clearing the first 60 cm of one cluster heading toward the centre mine after he cleared the 1st 60 cm by one 1m width with no signals he moved his base stick a head to clear the next 60 cm, then he stepped on the area which considered to be cleared by the same deminer, accidentally his foot went down due to the soil collapse under his foot (loose soil), the mine was in a depth of about 30 cm that when the deminer foot dived in the loosen soil he applied a pressure on the mine which activated the mine and caused the accident, note that from the accident result there was no direct contact between the deminer foot and the mine.

[The accident site, behind the base-stick in the area considered "cleared" by the deminer.]

This accident is classed as a *Missed mine accident* because the photograph showed that the site of the initiation was behind the base-stick and between the side of lane markings – so in an area that the deminer had “cleared”.

The primary cause of this accident is listed as *Victim inattention* because the Victim had not located the mines when using his detector and had not used the demining group's excavation/detector drill appropriately enough to find a mine at this depth. (This drill is designed to locate mines that are too deep for the detector to locate without removing some of the ground. The ground he stepped on had been loosened, but had not been removed and searched with the detector appropriately.) The secondary cause is listed as a *Management Control Inadequacy* because the investigator concluded that no mistakes had been made, when clearly some had. If management does not recognise an error, it will not be corrected. The investigator's failure to check the performance of the metal detector was unusual and appears to have been an oversight.
