# DDASaccident644

# DDAS Accident Report

**Incident investigation [Demining group] – MINE ACTION TEAM - JORDAN**

**IMSMA DETAILED REPORT FOR MINE INCIDENT, Sunday, 11 July 2010**

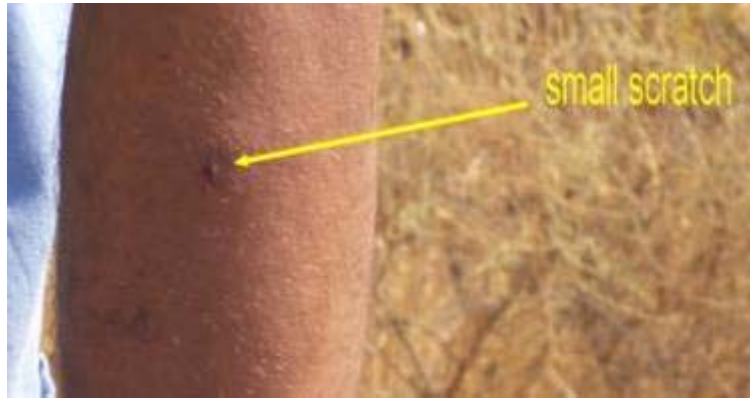
[The report included a photograph of a small scratch on the Victim's arm (he appears to have been working with his sleeves rolled up).]

INJURIES: minor Arm

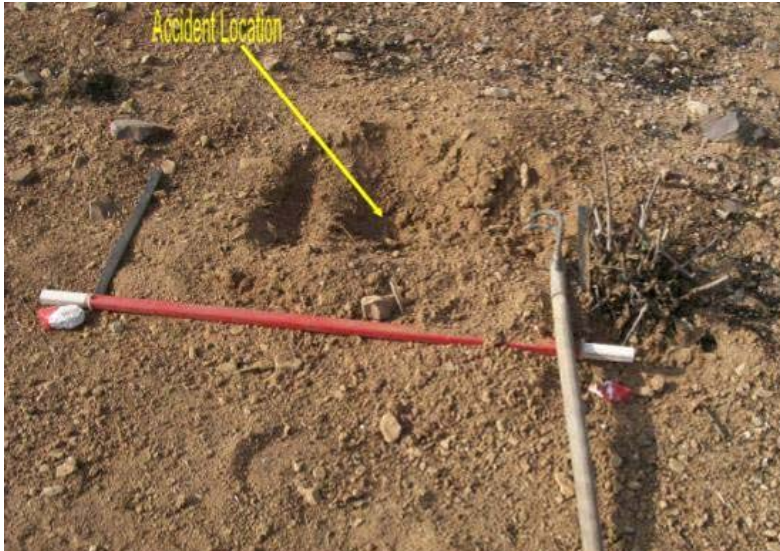
17. Comments (include measurements of any crater resulting from the explosion): Crater  
Depth: approx. 20 cm / Width: approx. 40 cm

[The accident site.]

Marking system was not applied on the ground during approaching to the mine. Triangle marker drill was not applied on the ground during excavation. Guessing and scratching were noted on the ground around the incident area. Approaching to the mine was done from both sides, left and right

The photos and investigating the incident site shows that the deminer make some changes to the incident site (which is against the [Demining group]/NBP SOP) and a lack of supervision and control from the team leader.
