### DDASaccident645

# DDAS Accident Report

INCIDENT INVESTIGATION FOR [Demining group] - MINE ACTION TEAM - JORDAN

TASK NAME: JABIR 1 (477), NORTH BORDER PROJECT, EAST SECTOR

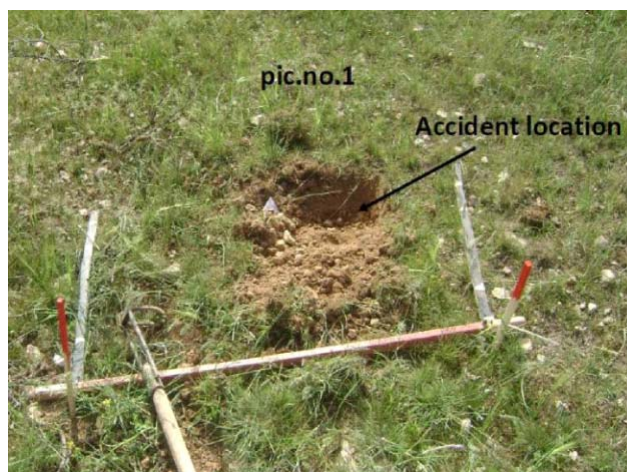
1. The deminer didn't carried out the visual check it was found there was stones in the clearance box.
2. He didn't apply the correct procedures in cutting the grass and removing stones according to the SOPs.

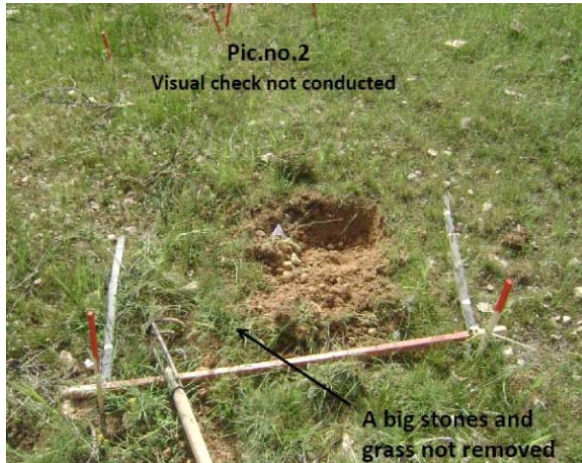
3. The base stick is placed in the right place and marked.
4. The deminer searched and carried out the raking for the signal outside the clearance box area.
5. The marking pickets are put according to the SOP.
6. No damage found in the heavy rake.
7. Raking depth was 11 cm which is less than the required depth.
8. The deminer buried the grass on his left side near to the cluster where he is working at instead of putting them in the rubbish pit it is violation of the SOPs.
9. He didn't use the light rake.
10. According to the medic who was watching when the accident happen it was a strong explosion followed by lots of dust.
11. There was no crater found after the mine blast which means that the mine was almost on surface or semi surface.

The deminer has not followed the correct drill. Using heavy rake in grass area is always risky due to the roots and due care should be taken. This incident happened due to the deminer individual mistake.

It is recommended to issue a written warning order to the deminer.
