DDASaccident670

DDAS Accident Report

INCIDENT INVESTIGATION [Demining group] – MINE ACTION TEAM - JORDAN

TASK NAME AL TURRAH 3 (410), NORTH BORDER PROJECT, EAST SECTOR

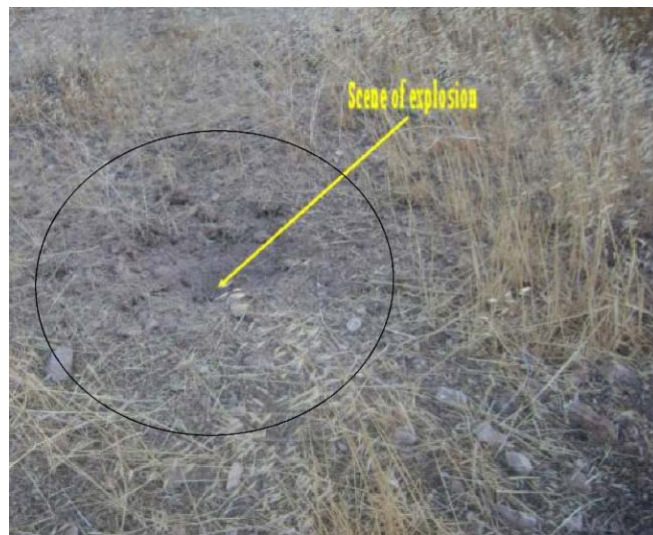
- 18. Describe the conditions at the site at time of the incident
- Ground/Terrain: Hard, flat
- Weather: Clear, Hot
- Vegetation: Medium, Bush

[The accident site showing dry grass and stony ground.]
