# DDASaccident675

# DDAS Accident Report

TASK NAME AL SHAJARAH 3 (412), NORTH BORDER PROJECT, EAST SECTOR

MINEFIELD NO.- 412, MINEFIELD TASK ID- E 412 AL SHAJARAH 3. SECTOR: - EAST

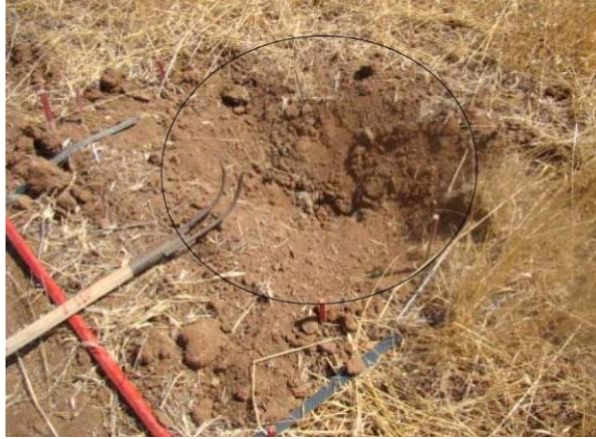
[Picture of the accident site.]

17) Crater depth approx 15cm, Width approx 40cm.

The secondary cause is listed as a *Field Control Inadequacy* because, despite the statements and the narrative, in the photograph of the blast crater there is no evidence of any excavation having been conducted to 20cm around that area before the blast occurred. The mine was almost certainly initiated by "hacking" at the ground with the heavy rake, which is not approved in the demining group's SOPs.
