DDASaccident676

DDAS Accident Report

Incident investigation for [Demining group] – MINE ACTION TEAM - JORDAN

IMSMA DETAILED REPORT FOR MINE INCIDENT Sunday, 20 June 2010

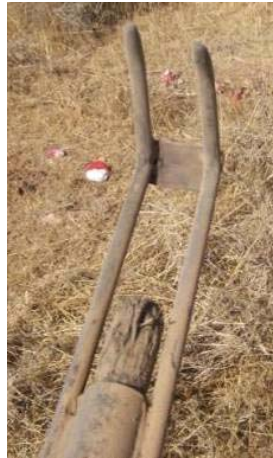
Heavy Rake, Damaged (not reusable)

[The bent rake-head.]

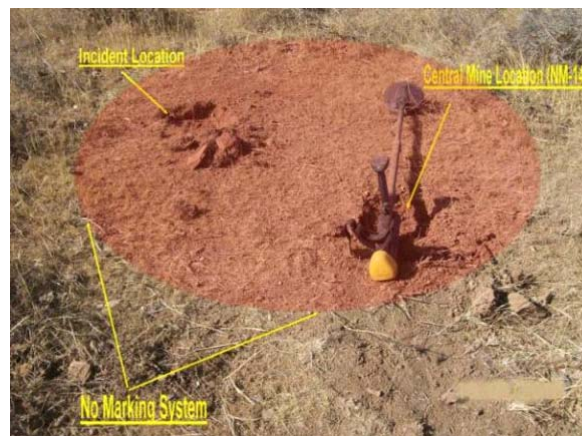
Findings:

Approaching drill to the target not as per as SOP.

No use for the marking system.

No use for base stick during the work.

No use for the light rake.

The recommendations is to give the deminer a final written warning and bring the attention for the team leader to give more focus on the deminer to make sure that he will not be in a danger and if he commit any mistake he have to be suspended directly and terminated.
