DDASaccident693

DDAS Accident Report

Incident investigation for [Demining group] – MINE ACTION TEAM - JORDAN

Task Name: shajarah 2 (411), north border project, NW SECTOR

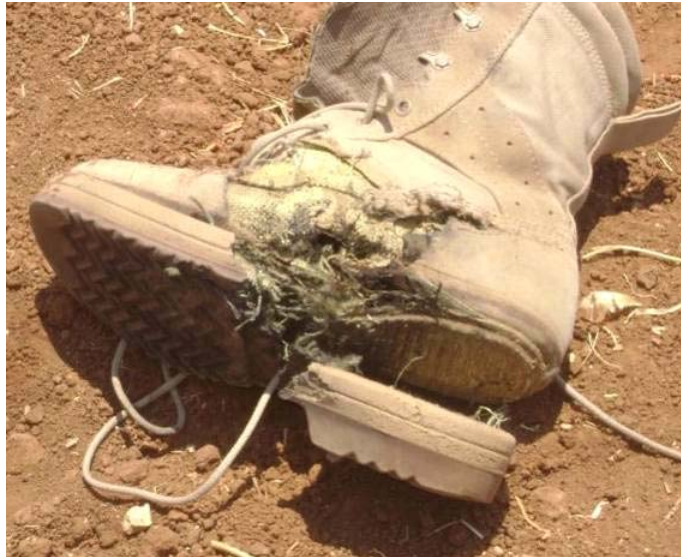
Demining Boot, [Blast boot] Damaged (Not Reusable)

[A photograph of the Victim's damaged BfR V-50 blast boot after the event.]

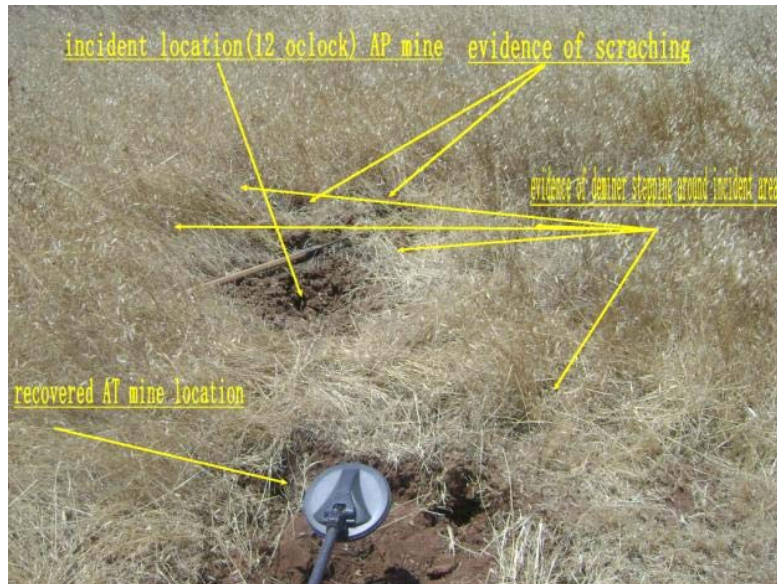
[The picture shows the detector in the foreground and a Heavy rake above the initiation site – so implying that the rake was in his hand at the time.]

The deminer was not following the proper procedure and he tried to locate the mine by guessing using the heavy RAKE, finding the heavy RAKE in that distance away from the base stick supporting this scenario.

Although the deminer may have had his detector in his hand at the time, the presence of the Heavy rake above the seat of the ignition, coupled with a lack of marking and a general disregard for the SOPs, suggest that this was a *Missed mine accident* and the Victim held the Heavy rake in his hand when he stepped on the mine.

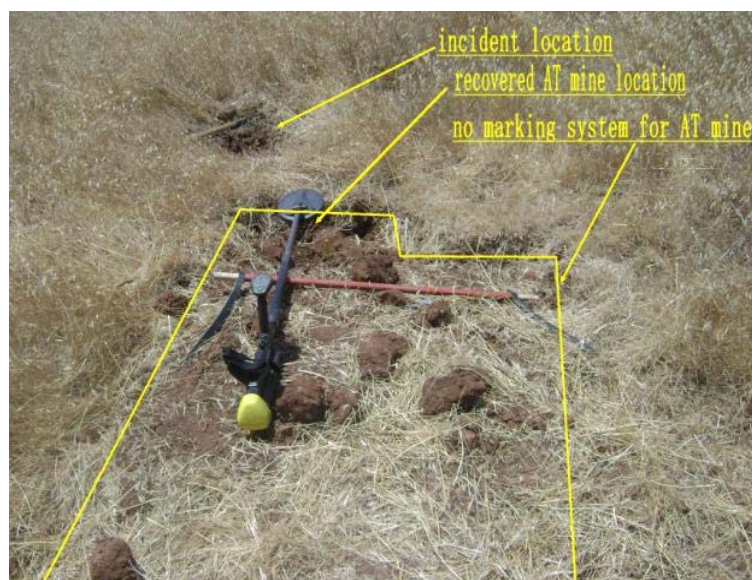
From the incident result it is clearly obvious that the mine was not buried deeper than 20 cm, which mean that using the MD with the combination method the mine will be located and recovered safely, the metal detector checked directly after the incident and it was operating properly, but its look like the deminer was applying one of the following scenarios:

The deminer was using the metal detector from a long distance away from the surface of the ground more than 10 cm (see the photo), the vegetation, the site of the incident crater support this scenario.

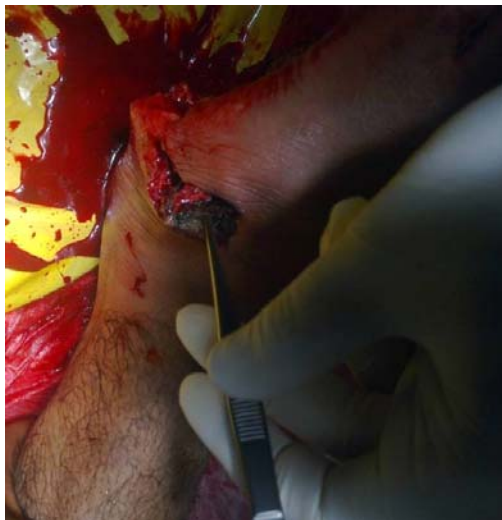
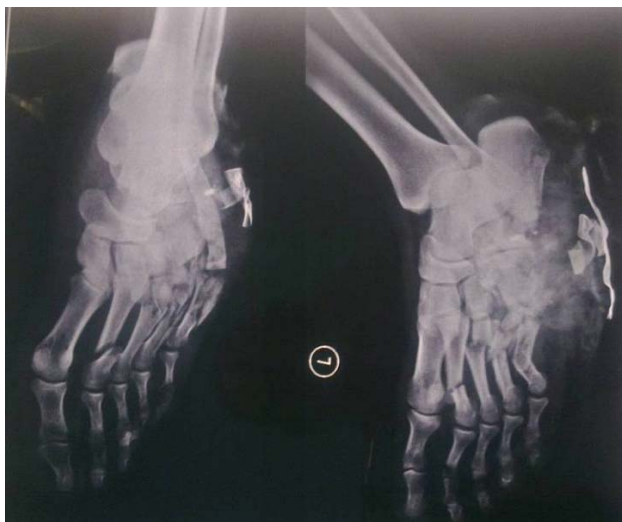
COMMENT: "comminuted metatarsal fracture with penetrating wound in his left foot". See Medical report.

A Medical report in Arabic is held on file. The pictures below show the wound (open at the side and top of the foot) and the X-ray of the foot.
