DDAS Accident Report

Report date: 07/03/2011	Accident number: 693
Accident time: 10:05	Accident Date: 26/07/2010
Where it occurred: Mf:411,, Sharajah 2, NW Sector, Ramtha Region	Country: Jordan
Primary cause: Field control inadequacy (?)	Secondary cause: Management/control inadequacy (?)
Class: Missed-mine accident	Date of main report: Not recorded
ID original source: None	Name of source: Demining group
Organisation: [Name removed]	
Mine/device: M14 AP blast	Ground condition: dry/dusty grass/grazing area rocks/stones soft
Date record created:	Date last modified: 07/03/2011
No of victims: 1	No of documents: 2

Incident investigation for [Demining group] – MINE ACTION TEAM - JORDAN

Task Name: shajarah 2 (411), north border project, NW SECTOR

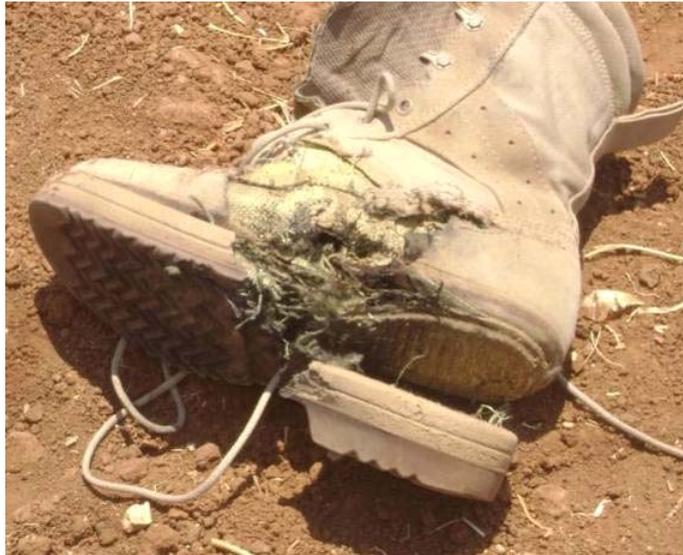
Demining Boot, [Blast boot] Damaged (Not Reusable)

[A photograph of the Victim's damaged BfR V-50 blast boot after the event.]

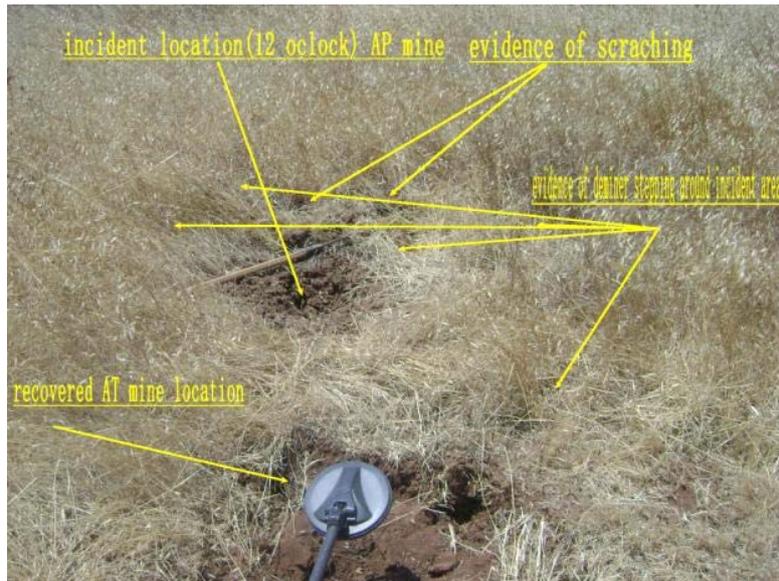
[The picture shows the detector in the foreground and a Heavy rake above the initiation site – so implying that the rake was in his hand at the time.]

The deminer was not following the proper procedure and he tried to locate the mine by guessing using the heavy RAKE, finding the heavy RAKE in that distance away from the base stick supporting this scenario.

Although the deminer may have had his detector in his hand at the time, the presence of the Heavy rake above the seat of the ignition, coupled with a lack of marking and a general disregard for the SOPs, suggest that this was a *Missed mine accident* and the Victim held the Heavy rake in his hand when he stepped on the mine.

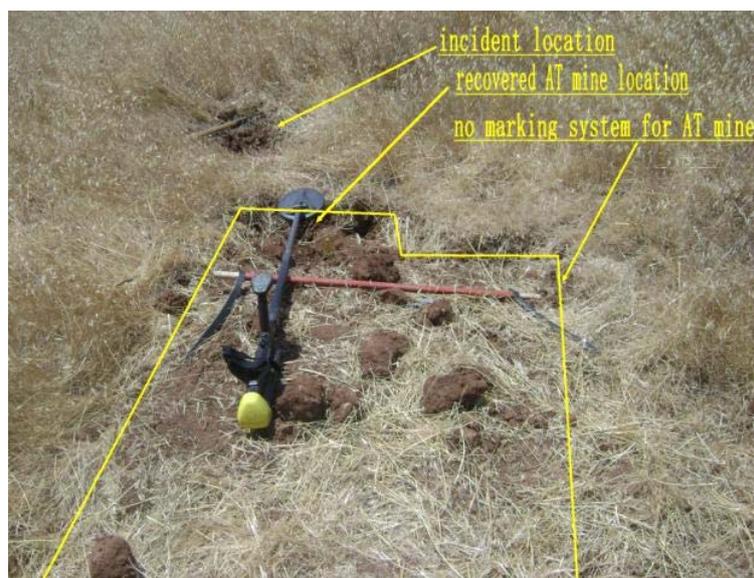
From the incident result it is clearly obvious that the mine was not buried deeper than 20 cm, which mean that using the MD with the combination method the mine will be located and recovered safely, the metal detector checked directly after the incident and it was operating properly, but its look like the deminer was applying one of the following scenarios:

The deminer was using the metal detector from a long distance away from the surface of the ground more than 10 cm (see the photo), the vegetation, the site of the incident crater support this scenario.

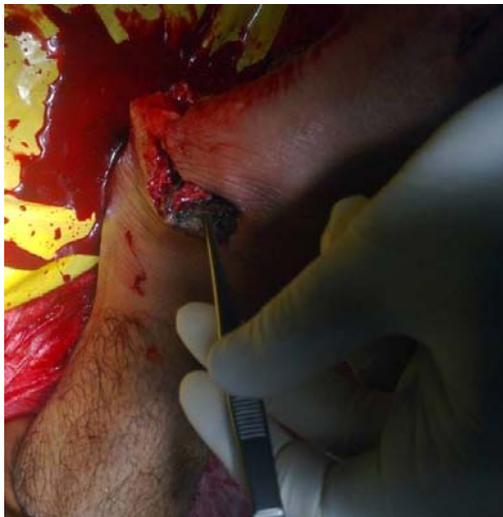
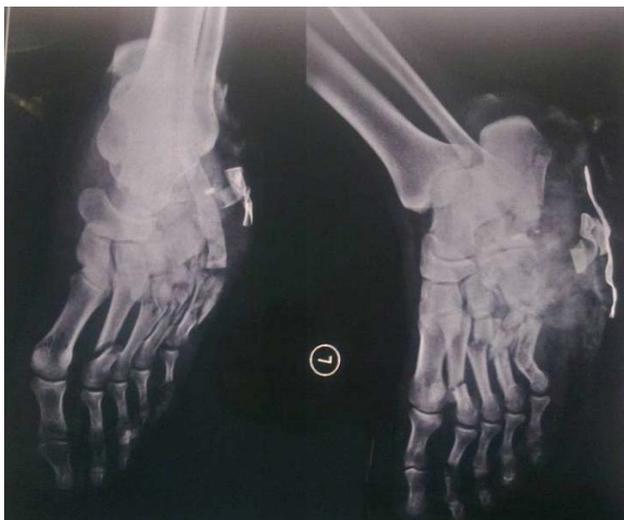
COMMENT: "comminuted metatarsal fracture with penetrating wound in his left foot". See Medical report.

A Medical report in Arabic is held on file. The pictures below show the would (open at the side and top of the foot) and the X-ray of the foot.
