DDASaccident699

DDAS Accident Report

INCIDENT INVESTIGATION FOR [Demining group] – MINE ACTION TEAM - JORDAN

TASK NAME AL SHAJARAH 1 (387), NORTH BORDER PROJECT. EAST SECTOR

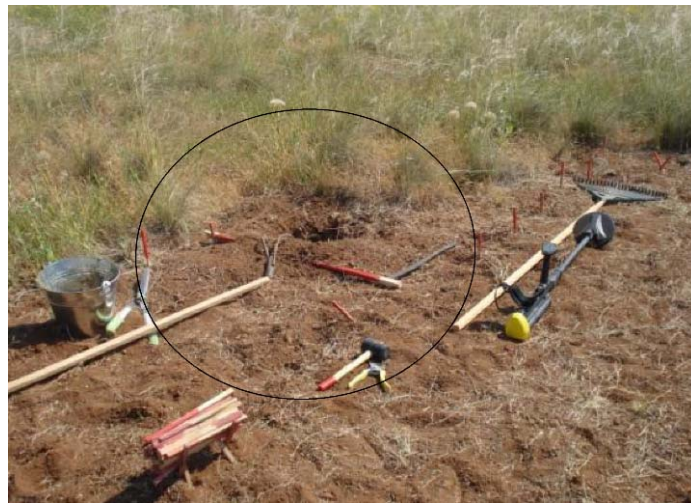
12. Did the incident result in any damage to equipment or property? No
13. List any mine action equipment or property damage: [None listed but the photograph below shows that the head of the Heavy Rake is damaged.]
14. List damage to equipment or property owned by a member of the public or the government. [None]

Crater Depth: approx. 15 cm / Width: approx. 40 cm

[The accident site]

According to the preliminary investigation the deminer approached to the mine using the proper procedure (15 cm from the side and front), but the depth was less than 15 cm, and the mine was deeply buried (about 18 cm).

Like incident can be avoided within the similar area where we expect the mines to be more than 15 cm depth by increasing the approach depth to 20 cm.
