DDAS Accident Report

Report date: 07/03/2011	Accident number: 701
Accident time: 13:33	Accident Date: 27/09/2009
Where it occurred: MF 362, Al Akaider Village, Almafraq Province	Country: Jordan
Primary cause: Unavoidable (?)	Secondary cause: Unavoidable (?)
Class: Excavation accident	Date of main report: Not recorded
ID original source: None	Name of source: Demining group
Organisation: [Name removed]	
Mine/device: M14 AP blast	Ground condition: dry/dusty grass/grazing area
Date record created:	Date last modified: 07/03/2011
No of victims: 1	No of documents: 2

INCIDENT INVESTIGATION [Demining group] – MINE ACTION TEAM - JORDAN

MINEFIELD TASK ID - E 362AL AKAIDER 2

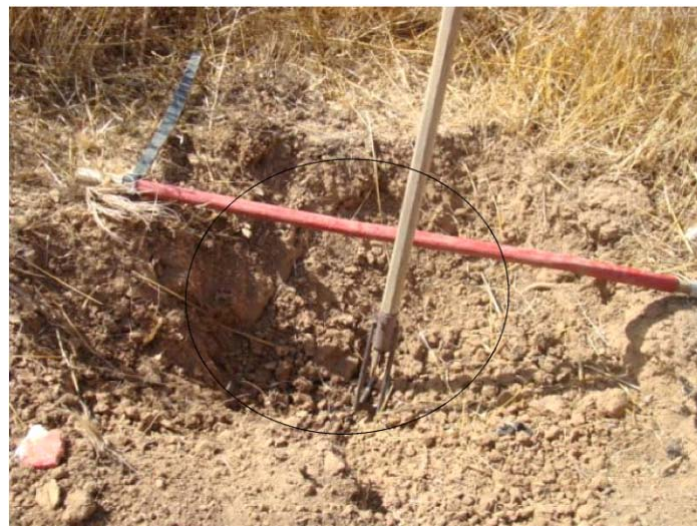
While the deminer was working in recovering one of the SMLs in Al Akaider 2 laid with 15 AP mines (M14) and after recovering 9 mines from the same SML and locating a signal in the predicted site for the 10th mine, the signal was strong and continuous which confused the deminer and there is no way to pin point an M14 mine at that area, the deminer start excavating the area from a depth for 40 cm using the heavy RAKE , the soil at that area hard that the deminer was using the RAKE in a hacking motion which caused a pressure on the mine pressure plate and initiate the mine about 2.2 m away from the deminer (the length of the RAKE handle).

17. Comments (include measurements of any crater resulting from the explosion): Crater Depth: approx. 15 cm / Width: approx. 40 cm

Ground/Terrain: Hard, Hillside

[The accident site.]

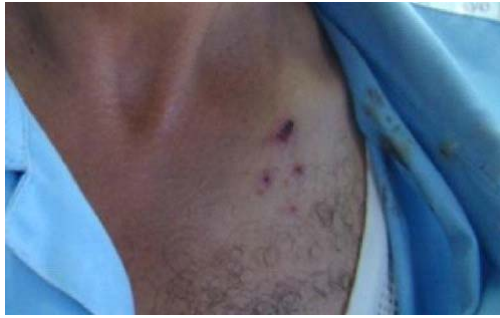
The deminer was investigating the signal while he was standing in lateral position not in a frontal way which makes it possible for the secondary fragmentation to find its way to the uncovered areas from the deminer body which described in the injuries.

A photograph showed a superficial wound just below the throat on the upper chest. See Analysis.

The unusual chest injury could have occurred with the deminer standing at an angle to the raked area (which is common) or standing straight on and leaning forward. This being the only record of a light upper chest injury while raking, it would be premature to consider redesigning the frontal PPE.

The minor chest injury
