DDASaccident706

DDAS Accident Report

INCIDENT INVESTIGATION [Demining group] – MINE ACTION TEAM - JORDAN

TASK NAME SABHA 8 (399), NORTH BORDER PROJECT, EAST SECTOR

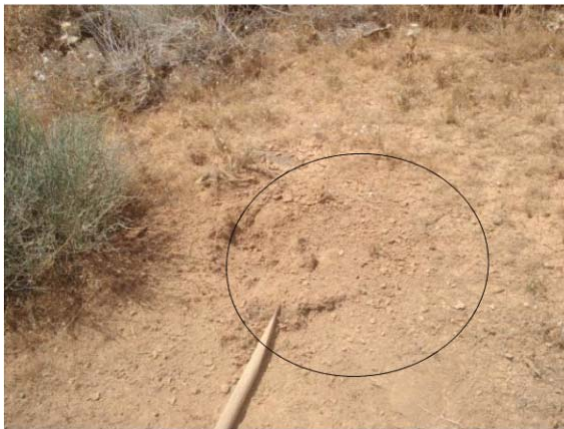
While the deminer try to recover one missing AP mine (M14) assigned for him by the team leader after grapping all the visible APs in the cluster and the central AT, the mine blasted 2.2 metres away from the deminer while searching the area with the heavy RAKE after pinpointing a signal using the metal detector.

17. Comments (include measurements of any crater resulting from the explosion): Crater
Depth: approx. 15 cm / Width: approx. 40 cm

Yes, the accident happened while using the heavy rake and because of the existence of a buried stone which was hit by the rake and fell on the mine which made the accident.

The primary cause of this accident is listed as *Unavoidable* because it seems that Victim may have been working correctly when the accident occurred. The Secondary cause is listed as a *Field Control Inadequacy* because the investigators decided that the Victim was not working correctly and his error was not corrected. His digging on top of a metal detector signal may indicate poor training on metal detector pinpointing.
