DDAS Accident Report

Report date: 07/07/2011	Accident number: 709
Accident time: Not recorded	Accident Date: 28/03/2007
Where it occurred: Area 6, MF1580, Kfar Houne	Country: Lebanon
Primary cause: Management/control inadequacy (?)	Secondary cause: Field control inadequacy (?)
Class: Missed-mine accident	Date of main report: 10/04/2007
ID original source: BOI 006/07	Name of source: UN MACC SL
Organisation: [Name removed]	
Mine/device: No.4 Israel AP blast / frag	Ground condition: building rubble grass/grazing area steep slope
Date record created:	Date last modified: 07/07/2011
No of victims: 0	No of documents: 2

MINE INCIDENT REPORT 006/2007

INVESTIGATION REPORT ON TWO MISSED MINES AT MINEFIELD 1580, KFAR HOUNE [Confusingly, this report gives details of three mines, one of which was visible but outside the cleared area.]

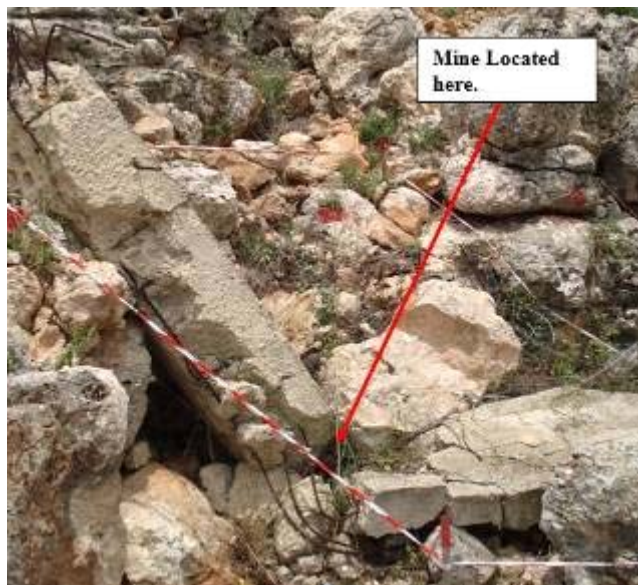
[Demining group 2] SL deployed several MCTs to the Sowaida position to remove the wire which had been left on the site by other clearance contractors, during the clearance of this wire one of the supervisors spotted the remains of an Israeli number 4 AP mine wedged into a large concrete beam which lay within an un-cleared area on the eastern side of the position. This was reported to [Demining group 2] SL Area 6 Operations Manager.

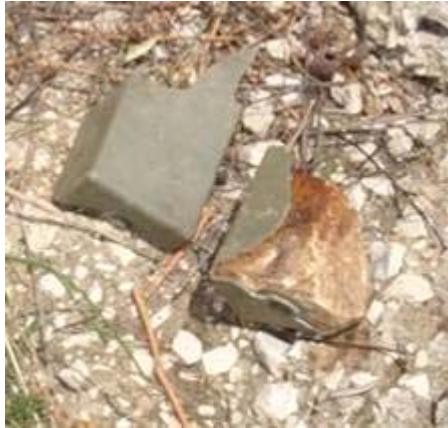
- The remains of the mine were un-fused.
- The mine case was broken where and the explosive content joins the fuse well.

- The rear of the mine case was open and some of the TNT fill was not present at the rear of the mine, the exposed TNT had been subjected to weathering and the TNT was black [brown], which would indicate that it has been exposed to the environment for an extended period of time.
- The forward edge of the mine had been shielded from the weather and the fuse well threads were undamaged which would indicate that the fuse had been removed rather than blown out by a detonation.
- Striation marks were visible on the plastic case of the mine which would indicate a blast had taken place at the rear of the mine.

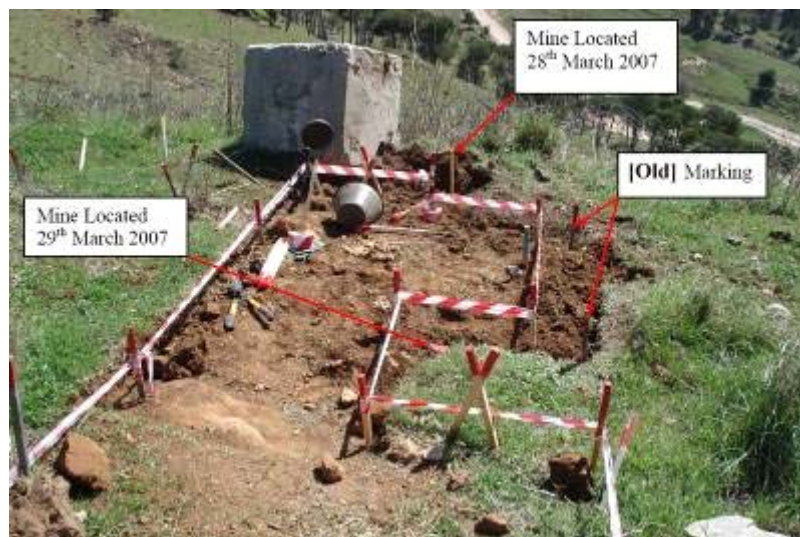
3. During clearance operations 28th March 2007 one Israeli Number 4A AP mine was located 4cm inside the [Demining group 1] clearance lane.
4. During clearance operations 29th March 2007 a further Israeli Number 4A AP mine was located in the marked and cleared [Demining group 1] clearance lane, this mine was photographed and destroyed to allow the clearance operation to continue.

[Photo clearly showing mines found inside the perimeter marked by old marking.]
