### DDASaccident720

# DDAS Accident Report

### **Incident investigation for [Demining group] – Mine Action Team – Jordan**

### **IMSMA DETAILED REPORT FOR MINE INCIDENT Monday , 21 March 2011**

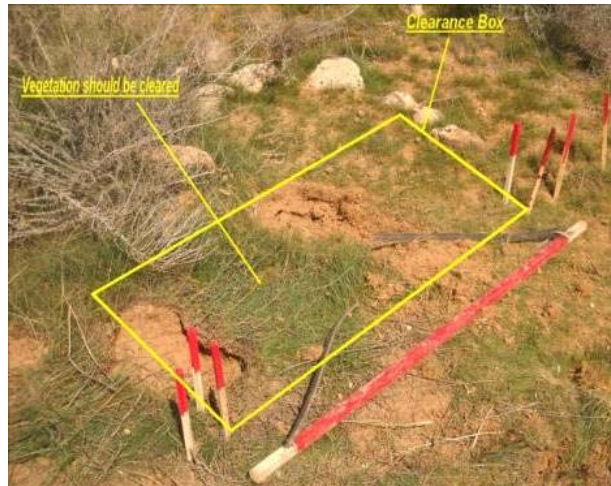
The deminer was working in IOE containing M14 AP mines in Section 3 in Sabha 11, he used the MD to indicate the location of the mine then used the light rake then excavated using the heavy rake, during the excavation for the mine using the heavy rake, the deminer hit accidentally the AP mine on the top which detonated the mine.

The accident site

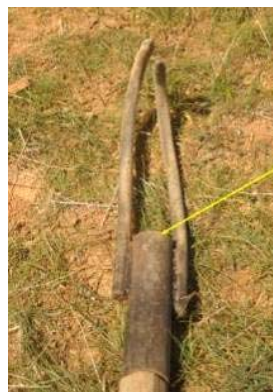
- 12. Did the incident result in any damage to equipment or property? Yes
- 13. List any mine action equipment or property damage: Heavy Rake, Damaged (Not Reusable)
- 14. List damage to equipment or property owned by a member of the public or the government. Include contact details of the owner or responsible person: None

The damaged Heavy rake
