# DDAS Accident Report

<b>Report date:</b> 08/07/2011	<b>Accident number:</b> 724
<b>Accident time:</b> 08:55	<b>Accident Date:</b> 21/12/2010
<b>Where it occurred:</b> MF 385, Kum Al Ruff Sabha 10, Mafraq, North Border Project	<b>Country:</b> Jordan
<b>Primary cause:</b> Victim inattention (?)	<b>Secondary cause:</b> Unavoidable (?)
<b>Class:</b> Handling accident	<b>Date of main report:</b> Not recorded
<b>ID original source:</b> None	<b>Name of source:</b> Demining group
<b>Organisation:</b> [Name removed]	
<b>Mine/device:</b> M-19 AT blast	<b>Ground condition:</b> dry/dusty hard
<b>Date record created:</b>	<b>Date last modified:</b> 08/07/2011
<b>No of victims:</b> 1	<b>No of documents:</b> 1

## Study and Analysis of the fatal AT accident

NBP — East Sector — Sabha 10 — MF 385

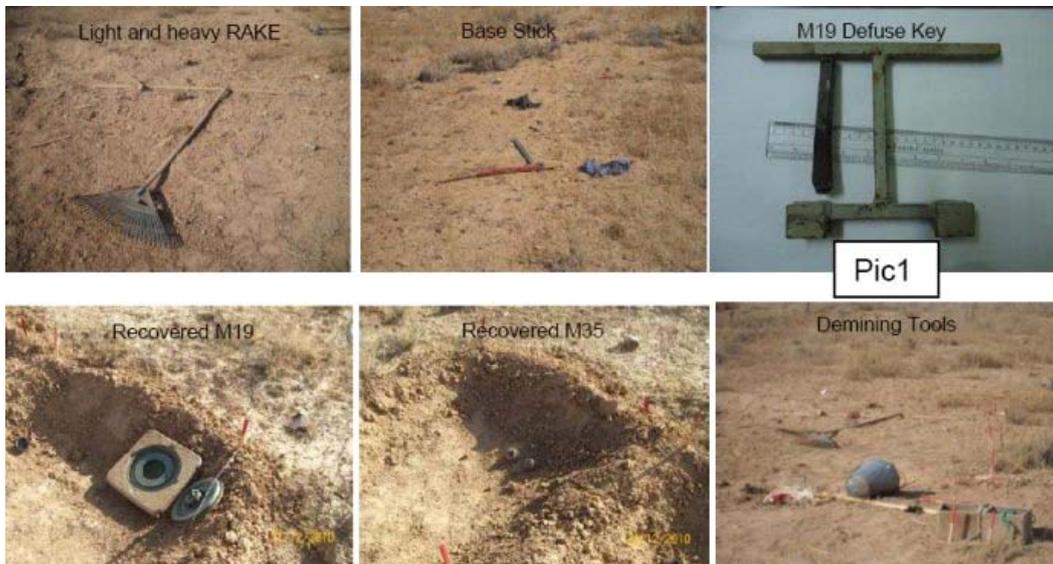
- 1. All the tools approved for the deminers found in the site with no damage except:
  - a. The base stick (found broken into two pieces).
  - b. The M19 defuse key (found broken and damaged).

Light and heavy RAKE                      Base Stick                      M19 Defuse Key  
Recovered M19                      Recovered M35                      Demining Tools

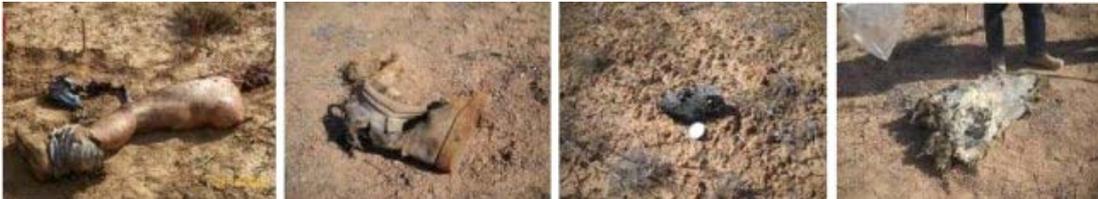
3. The deminer's body were totally over the mine except his left leg which was totally touching the ground away from the mine to the north east side and the right foot which was on the ground close to the mine from the north west side.
