DDAS Accident Report

Report date: 08/07/2011	Accident number: 725
Accident time: 09:00	Accident Date: 20/08/2007
Where it occurred: CBU 855, Area 1-001, Al Hinnieh	Country: Lebanon
Primary cause: Inadequate survey (?)	Secondary cause: Management/control inadequacy (?)
Class: Missed-mine accident	Date of main report: 24/08/2007
ID original source: 013/07	Name of source: UN MACC SL
Organisation: [Name removed]	
Mine/device: M77 submunition	Ground condition: agricultural (recent)
Date record created:	Date last modified: 08/07/2011
No of victims: 0	No of documents: 1

BAC INCIDENT REPORT 013/07

Report on Incident that occurred on the 20th August 2007 at CBU 855, Area 1, Al Hinnieh

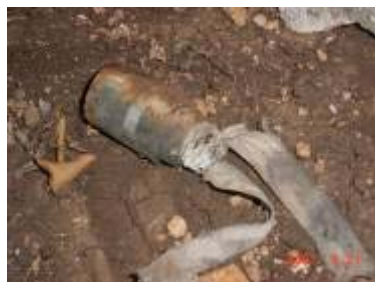
[The M77]

The sub munition was a M77, intact and showed traces of rust on the outer casing

The M77 was located on top of the surface.

The local worker stated the M77 was found in July 2007 subsurface. The orchard has been watered since the findings and now found the second time subsurface.

The BACTEC EOD team will be called out remove or destroy the M77.

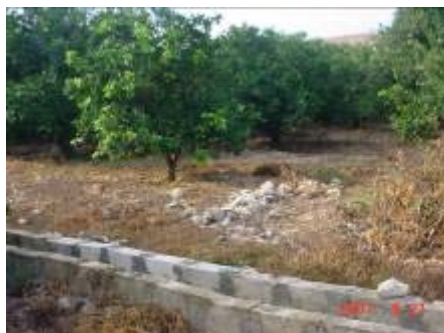
6. On arrival at the incident site, it was ascertained that there is safe access from the control point to the incident site without additional clearance being conducted.

[The site]

The location of the sub-munitions was identified as in an area that surface clearance had taken place.

The primary cause of this incident is listed as *Inadequate survey* because the area had been tasked for a superficial surface (visual) clearance when at least one submunition had gone subsurface. The secondary cause is listed as a *Management control inadequacy* because the report makes no recommendation that the MACC SL who allocated the Task should correct their survey error after finding that it was inappropriate. It is remarkable that the report makes no recommendations for a secondary, subsurface clearance of an area where a device had been located subsurface. It is also strange that the investigator decided that the area was safe to enter and continue a visual Quality Assurance check when fully aware that sensitive items might be below the surface. The apparent irresponsibility of the management group is unusual. Because the investigation was carried out by the organization that made the errors, this incident is listed under Notes as having had "No independent investigation".

The Sampling team continues to work on CBU 855 as directed.

Normal site setup is to continue as per SOP.
