DDAS Accident Report

Report date: 09/07/2011	Accident number: 731
Accident time: 10:28	Accident Date: 17/04/2011
Where it occurred: Task No: Sabha 10/ (385), Kum Al Ruff Village, Mafraq Province, East Sector.	Country: Jordan
Primary cause: Unavoidable (?)	Secondary cause: Unavoidable (?)
Class: Excavation accident	Date of main report: None
ID original source: None	Name of source: Demining group
Organisation: [Name removed]	
Mine/device: M14 AP blast	Ground condition: hard rocks/stones
Date record created:	Date last modified: 09/07/2011
No of victims: 2	No of documents: 2

Incident investigation For [Demining group] Mine Action Team, Jordan

Task Name: Sabha 10 (385)

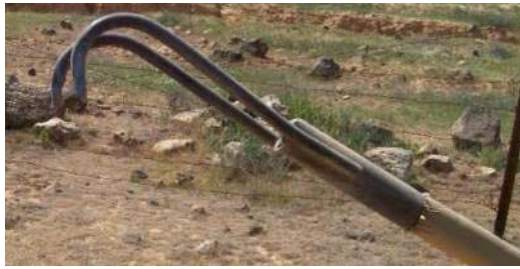
13. List any mine action equipment or property damage: Heavy Rake, Damaged (Not Reusable)

Damaged Heavy rake

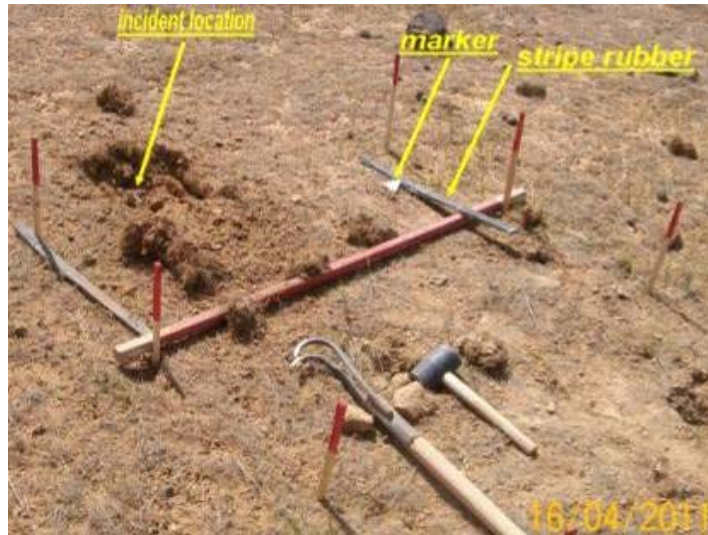
17. Comments (include measurements of any crater resulting from the explosion): Crater Depth: approx. 10 cm / Width: approx. 26 cm

Ground/Terrain: Flat, Hard, Open

Accident site

The deminer did not use the light rake although the detonated mine was not deep buried and this can be known by the depth of the blast crater which is less than 10 cm .

Incident area must be closed directly after the incident but a new pinpointing marker was seen in the incident location which means that this marker was put after the incident and also the metal detector was outside the incident area (closing the incident area is the responsibility of the deminer and the team leader).
