# DDASaccident738

# DDAS Accident Report

## **BAC INCIDENT REPORT 007/2007**

Report on Incident that occurred on the 14th April 2007 at CBU 19, Area 4 Et Taibe.

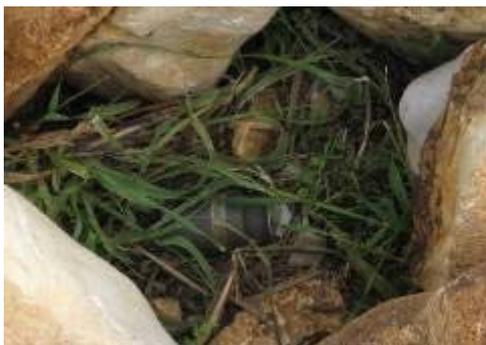
[The discovered submunition inside a ring of marking stones.]

- The sub-munition was clearly visible and showed no signs of being buried earlier.
- The sub-munition was not marked in accordance with [Demining group] SOP.
- The location of the sub-munition was in a visually searched area.

- The sub-munition was left unmarked from Saturday (14th April 2007) until being disposed Tuesday (17)
- It is inconclusive as to whether the sub-munition was not located during the clearance, or if the item has subsequently been delivered to the site after clearance.

The demining group marked the device by placing a ring of large stones around it. This is an effective informal marking system that is widely used and prevents people stepping on the item unintentionally. The investigators criticised them for not using the right marking without seeming to realise the purpose that marking serves.

- Regardless of when or where a situation like this occurs, the munition must be properly marked as per SOP and disposed of as soon as possible.
- Follow up clearance be conducted around the area of the location of the sub-munition.
- Revise visual clearance drills to confirm [Demining group] procedures.
