# DDASaccident741

# DDAS Accident Report

## **INTERNAL INVESTIGATION REPORT [Demining group], KABUL November 2007**

## **LESSONS LEARNED SUMMARY OF DEMINING ACCIDENT OCCURRED TO [Demining group] EOD-12 ON 12 NOVEMBER 2007**

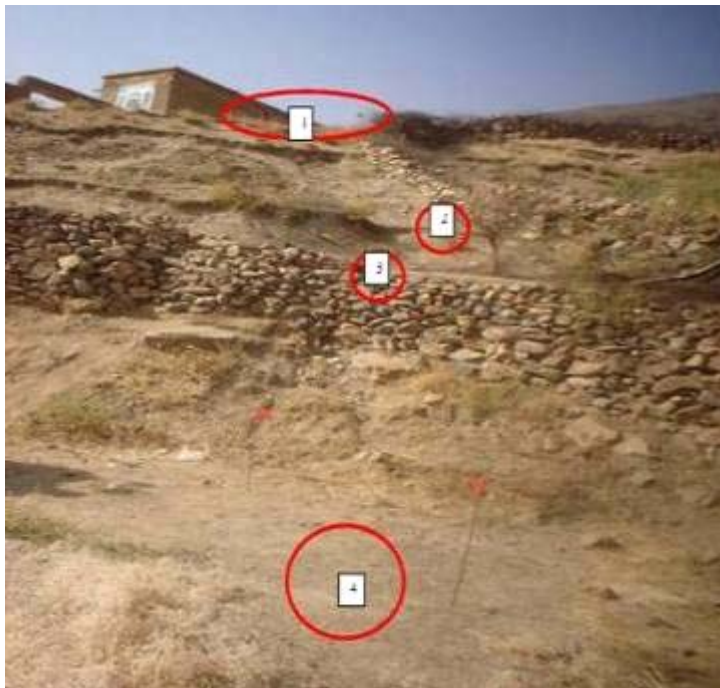
[The accident site]

On 12 November 2007 Section No. 1 started its normal work and identified a PD fuse at Location 2 shown in the picture below.

[The Victims] - operators of EOD 12 - were following the MCT section for categorisation of marked UXO. The PD fuse located at Location 2 was categorized as safe and [Victim No.2] handled it from Location 2 onto the rock wall between himself and [Victim No.1] who was situated at Location 4. [Victim No.1] was to retrieve the PD fuse from the wall and move it to field UXO Collection Point. The PD fuse has fallen from the wall to the ground and detonated, resulting in the two casualties.

Legend:

BAC searching line location during accident - 1

Marked UXO by BAC Section - 2

Handling of UXO by [the Victims] - 3

Accident point and [Victim No.1] location - 4

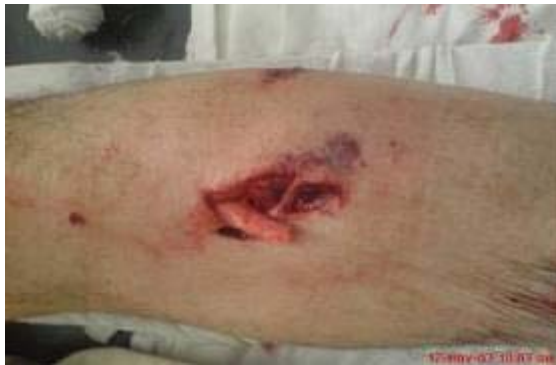
### A. Patient 1 – [Victim No.1]

Left leg below Knee joint open fracture of Tibia shaft near to proximal end laterally. The bone fractured pieces were on multiple different lines but the fibula bone was remaining safe and secure.

Multiple fragmental wounds on:

- Small fragmental wounds on anterior view on right leg below knee joints
- Anterior view on left inguinal.

- Left infra chest medclavicular lines both side.
- Anterior view brachial area proximal to shoulder.
- Anterior view on forearm proximal to elbow joints.

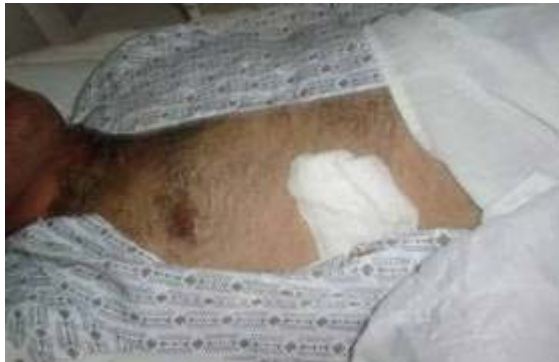
### **B. Patient 2 – [Victim No.2]**

A small fragmental wound on anterior view of chest inferiorly (May chest hole) unknown.
