DDAS Accident Report

LAF SAMPLING TEAM INVESTIGATION REPORT FOR [Demining group] BAC
SUBSURFACE CLEARED SITE AT TASK CBU- 203

Date: 11.07.2007

Task: CBU- 203,

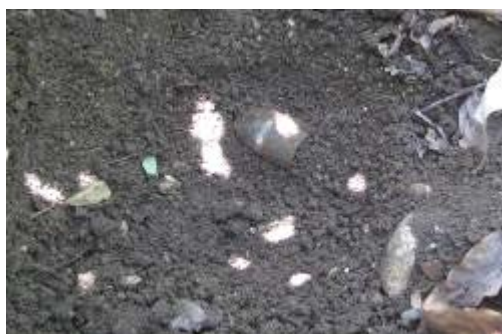
Sampling Team located submunition M77 on CBU 203 in cleared and completed area by [Demining group].

Item found in depth 5cm.

[M77 as found]

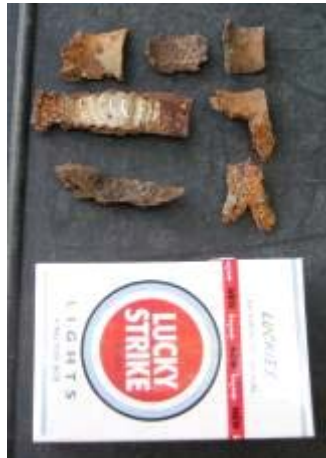
[Other photographs showed significant other amounts of metal found during the check. The demining group was clearing with metal-detectors so should have left cleared ground metal-free.]

The primary and secondary cause of this accident are listed as *Field control inadequacy* because the demining group was clearing using Minelab metal detectors and apparently left significant metal behind, including at least one M77 submunition. The only explanation for so much metal being left is that the search was not conducted appropriately and parts of the Task area were not searched. This is the “Inadequate training” referenced under Notes.
