## DDASaccident746

# DDAS Accident Report

### **Incident investigation for [Demining group] Mine Action Team, Jordan**

### **IMSMA DETAILED REPORT FOR MINE INCIDENT, Monday , 11 April 2011**

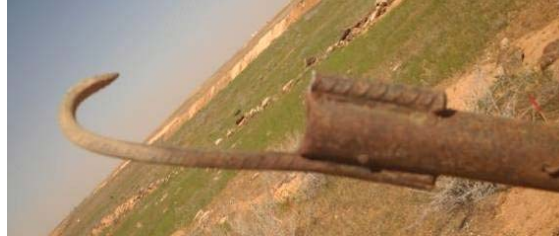
The deminer was working in SML D which contains M14 AP mines, he indicated the location of the mine then used the light rake then excavated using the heavy rake, during the excavation for the mine using the heavy rake the deminer accidentally caused a pressure on the AP mine pressure plate which caused the detonation.

13. List any mine action equipment or property damage: Heavy Rake, Damaged (Not Reusable)

The damaged Heavy rake

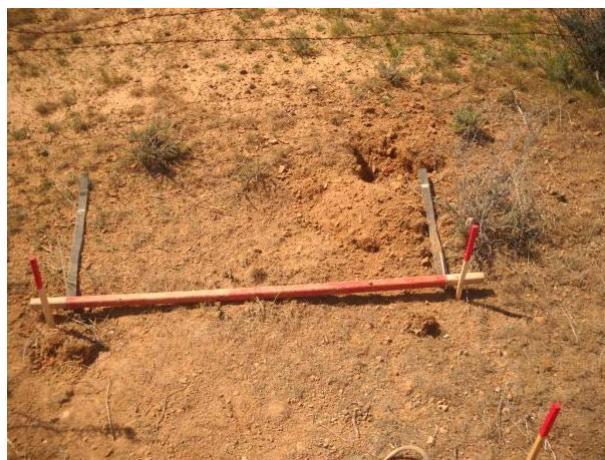
17. Comments (include measurements of any crater resulting from the explosion): Crater Depth: approx. 13 cm / Width: approx. 15 cm

Ground/Terrain: Flat, open

The accident site
