# DDASaccident751

# DDAS Accident Report

## BAC INCIDENT REPORT 005/2007

### INVESTIGATION REPORT ON MISSED M77SUB-MUNITION AT CBU 127, AREA 8 HOLUSIEHI

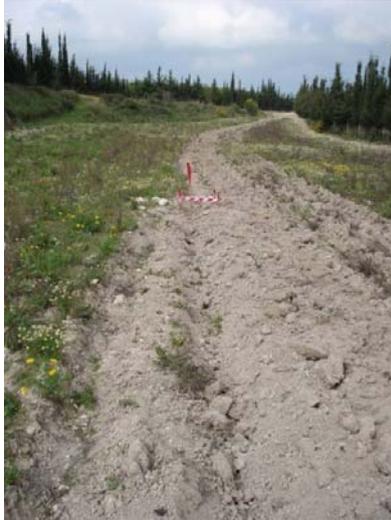
The M77 was located in an area previously ploughed up by the owner before clearance work started, using the same attachment (Ripper).

[The ploughed area]

The freshly ploughed area was ploughed using a single ripper attached behind the tractor. This rips down up to 30cm below the surface of the ground.

In this particular spot it had been ploughed down to approximately 26cm

On the investigation of the trench a patch of corroded material was noted on the side wall of the trench below 20cm.

This patch was removed and inspected. Dark paint was embedded in the soil that resembled the paint missing on the M77.

Particular attention should be paid to areas previously ploughed / disturbed where the presence of sub munitions have been confirmed.
