# DDASaccident756

Humanitarian Demining Accident and Incident Database  
*AID*

# DDAS Accident Report

**BAC INCIDENT REPORT 001/2007**

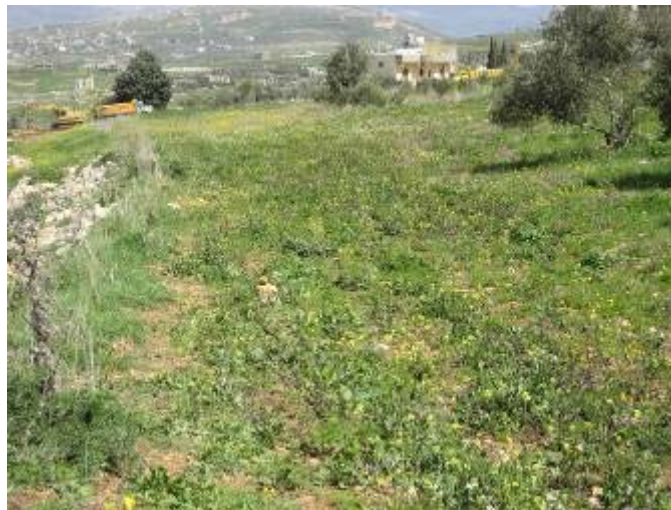
The ground is flat, comprising compact soil and covered in short vegetation. The M-77 submunition was surrounded on three sides by light vegetation and positioned on its side with approximately two thirds buried. The location of the submunition had been marked by [Demining group] with red spray paint (boundary), red sprayed rocks (to one side) and red / white danger area marking tape (boundary).

The large rock marks the location

[Demining group] have completed verification of the immediate area of the incident by clearing a 50m<sup>2</sup> box around the submunition using sub-surface BAC procedures. No items of ERW were located.

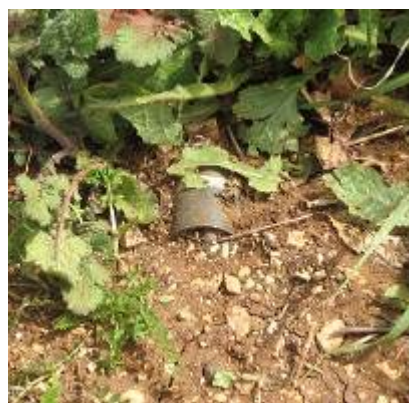
The M77 submunition

The submunition was positioned on its side, with approximately 2/3 buried, and was surrounded by light vegetation. According to [Name removed] (MACC CLO), the shepherd had removed some of the vegetation when he discovered it.

The submunition is considered as missed and should have been located by [Demining group] during the BAC operations.

[Demining group] shall conduct 1 day's refresher training for BAC Team 7 for surface BAC procedures prior to commencing operations.

[Demining group] Project Manager has submitted an amendment to their BAC SOP pertaining to visual / instrument assisted surface clearance. This procedure shall take immediate effect and the SOP shall be reviewed by the MACC SL.
