DDASaccident761

DDAS Accident Report

Report date: 15/07/2011	Accident number: 761
Accident time: Not recorded	Accident Date: 06/06/2007
Where it occurred: DA 483, See GPS coordinates	Country: Lebanon
Primary cause: Other (?)	Secondary cause: Other (?)
Class: Missed-mine accident	Date of main report: 06/06/2007
ID original source: None	Name of source: UN MACC SL
Organisation: [Name removed]	
Mine/device: M77 submunition	Ground condition: rocks/stones route (verge)
Date record created:	Date last modified: 15/07/2011
No of victims: 0	No of documents: 1

Re: One M77 Sub munitions found in DA 483 by [Demining group] completed task.

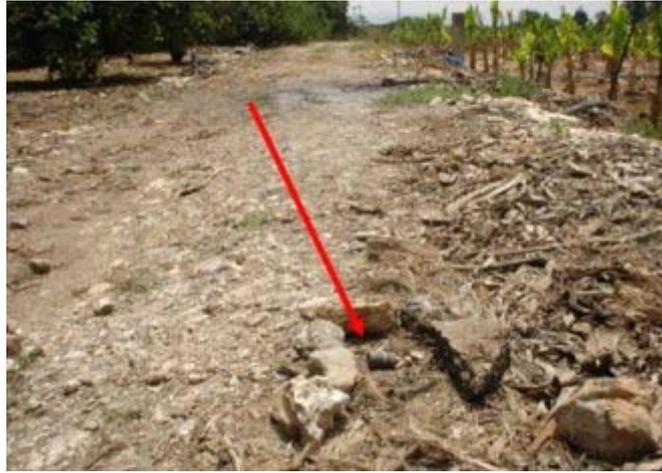
The item (M 77) was located on a road inside and between cleared areas. The road itself has been cleared and the item is so obvious that it cant been missed during clearance. See photo attached for road condition.

Red arrow points at M77 found. The road is a hard gravel road.

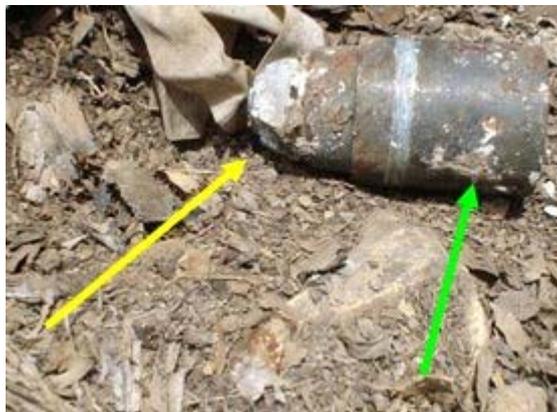
The M77 found was not armed.

There are indications that the M 77 has been in contact with stone suggesting that someone tried to detonate it by throwing it towards a stony area or even worse, hitting

it with stones. Since it wasn't armed no detonation was achieved and it was brought to the road and placed there right on the surface.

Yellow arrow points at Detonator sleeve in unarmed position
Green arrow points at area where the M 77 been in contact with stone
