DDASaccident762

DDAS Accident Report

BAC INCIDENT REPORT 009/2007

INVESTIGATION REPORT ON A MZD 2 SUB-MUNITION AT CBU 829, Area 2 Ayta Ash Shaab on the 5th May 2007

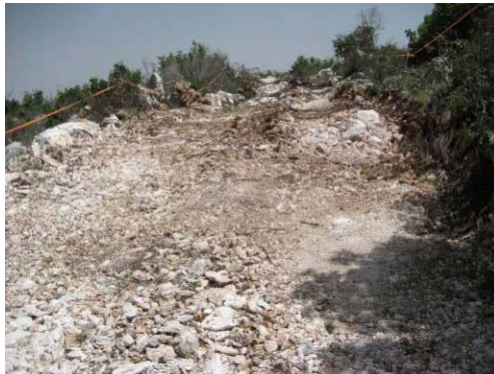
The accident site

- The land area in which the MZD 2 was located had been developed to allow the construction of an access road.
- A significant amount of earth and rocks had been relocated for other area to form the road.

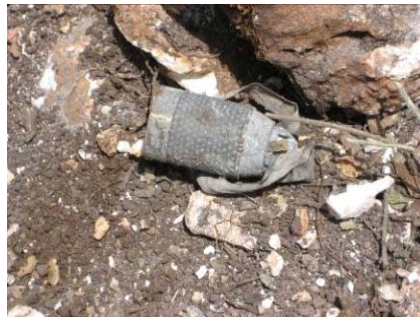
The MZ-2 submunition in-situ

- CBU 829 was previously surface cleared as part of a task dossier 2-007, and included CBUs 830 and 604, issued by the MACC SL to [Demining group].
- The location of the submunitions was identified as in an area that clearance had taken place.
- The MZD 2 was located at ground level, was in good condition, free of dirt and no damage was seen (see attached photos).
- An un-cleared area remains which may have MZD 2 located inside.
- The land owner wished to have the un-cleared area searched.
- It is unlikely that the MZD 2 sub-munitions would have been positioned in the location with little damage, free of spoil and completely above or on the surface given the amount of earthworks that was undertaken in the immediate and exact location of the MZD 2.

The primary cause of this Missed mine/device incident is listed as *Inadequate survey* because the area had been subjected to a surface search when it should have been sub-surface searched. The decision to conduct superficial surface search in areas where agricultural and construction activity would take place was the responsibility of the MACC SL, the same body

- CLOs to continue to warn local residence of areas have been cleared and the remaining un-cleared areas present a continued danger.
- Appropriate warning signs are erected in areas where there are un-cleared areas.
- Identify the un-cleared areas for future clearance priorities.
