# DDASaccident764

# DDAS Accident Report

MINE ACTION COORDINATION CENTRE, SOUTHERN LEBANON DEMINING INCIDENT  
REPORT 004/2007

**INVESTIGATION REPORT ON A M85 SUB-MUNITION AT CBU 519, AREA 3 AYNATA**

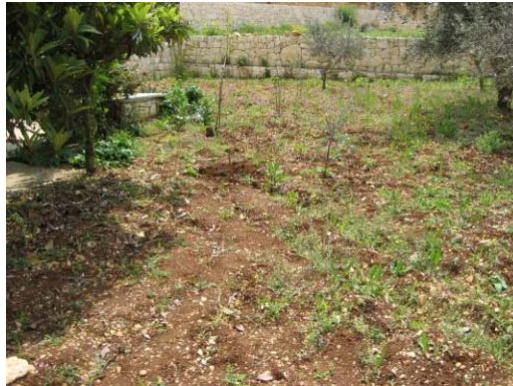
The accident site

- The land area in which the M85 had been situated had been ploughed
- The M85 detonation crater was clearly visible which indicated the M85 had been located below the surface
- The location of the M85 was identified as the area of the task that have been surfaced cleared
- The location of the M85 crater was approx. 10m from the front door of the property owner

- CBU 519 was previously surface cleared as part of a task dossier 3-001 issued by the MACC SL to [Demining group].
- The location of the sub-munitions was identified as in an area that surface clearance had taken place.
- The M85 was located below ground level, given the crater depth, from between 2 - 10cm
- The area of the incident was approx. 10m from the residence house.

- CLO/Ops to continue to warn local residence that the areas have been surface cleared only, still present a danger when any form of cultivation ploughing of the land occurs.
- Area's surface cleared immediately adjacent to residential housing areas should have follow up with sub-surface clearance.
- Appropriate warning signs are erected in areas where a site suspension has occurred.
- Notice boards are erected in the local village to continue to warn of the dangers of Sub-Munitions until the village has been cleared of the dangers.
