### DDASaccident765

# DDAS Accident Report

<b>Report date:</b> 15/07/2011	<b>Accident number:</b> 765
<b>Accident time:</b> 12:15	<b>Accident Date:</b> 03/12/2009
<b>Where it occurred:</b> AF0308/01635/5324, Qala-e-Ahmad jan village, Bagram District, Parwan Province	<b>Country:</b> Afghanistan
<b>Primary cause:</b> Inadequate training (?)	<b>Secondary cause:</b> Victim inattention (?)
<b>Class:</b> Handling accident	<b>Date of main report:</b> 09/12/2009
<b>ID original source:</b> None	<b>Name of source:</b> Demining group
<b>Organisation:</b> [Name removed]	
<b>Mine/device:</b> VOG-17, 30mm rifle grenade	<b>Ground condition:</b> soft wet
<b>Date record created:</b>	<b>Date last modified:</b> 15/07/2011
<b>No of victims:</b> 1	<b>No of documents:</b> 1

Detailed Demining Incident Report

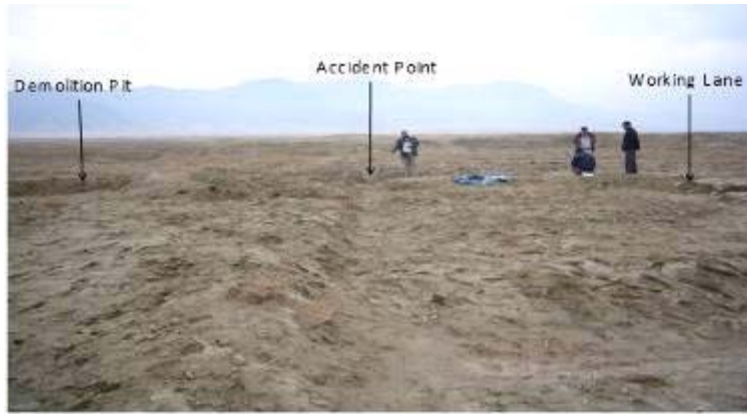
Overview

a. Worksite layout and marking. The incident location was seven metres away from the deminer's clearance lane. The area around the accident is a cleared area. Markings of the clearance lane were as per [Demining group] SOPs & AMAS. The Section Leader's location was approximately 30m away when the accident occurred. The ambulance pick up point was approximately 20m away. A sketch map is located at Annex A, in the Demining Accident Report. [Not made available.]

- a. As per the IMSMA Progress report dated 03/12/2009 one UXO had been located in the clearance lane.
- b. Details of the crater size. Diameter Approx 80cm, Depth Approx 20cm, fragments was found in close proximity to the incident site by team members. No other UXO or mines are located in the immediate area of the clearance lane where the incident occurred.

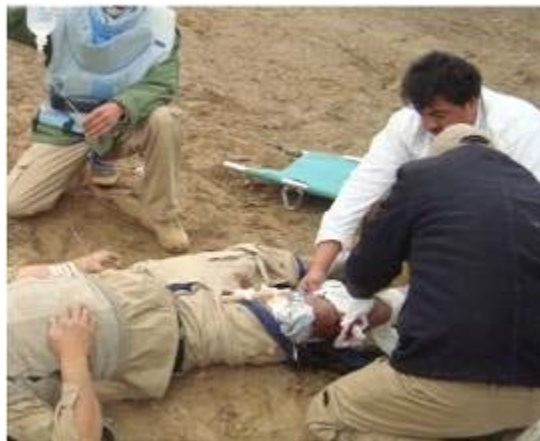
The patient has direct blast injuries below the knee on the right leg.

Bad Fractures, (Shattered) of the Tibia and Fibula bones.

[The Victim being treated in the field.]
