DDAS Accident Report

Report date: 15/07/2011	Accident number: 766
Accident time: 08:30	Accident Date: 03/04/2007
Where it occurred: CBU site 203, Batoulay, Ej-Jenoub, Area 7	Country: Lebanon
Primary cause: Inadequate survey (?)	Secondary cause: Management/control inadequacy (?)
Class: Missed-mine accident	Date of main report: 03/04/2007
ID original source: 003/07	Name of source: UN MACC SL
Organisation: [Name removed]	
Mine/device: M77 submunition	Ground condition: agricultural (recent) leaf litter soft
Date record created:	Date last modified: 15/07/2011
No of victims: 0	No of documents: 1

MINE INCIDENT REPORT 003/2007

INDEPENDENT INVESTIGATION REPORT FOR MINE INCIDENT IN BATOULAY - 03 April 2007, No 003/07

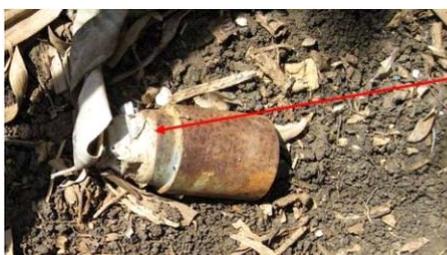
The M-77 was on the surface with remnants of paper tape around the fuze collar.

International Mine Action Organisations operating in Lebanon generally use plastic tape when rendering safe (gagging) submunitions therefore, it unlikely that the tape had been placed by them.

M-77
Remnants
of paper
tape around
fuze collar

The presence of “gagging” tape around the neck of an obvious submunition found on the surface implies that it had been found and moved by someone – perhaps to discredit the demining group – and this may explain why the investigators did not criticise the demining group about its inadequate perimeter marking.

The M-77 is disposed of as a matter of urgency. [Name removed] has confirmed that [Demining group] will destroy the item in situation the same day.

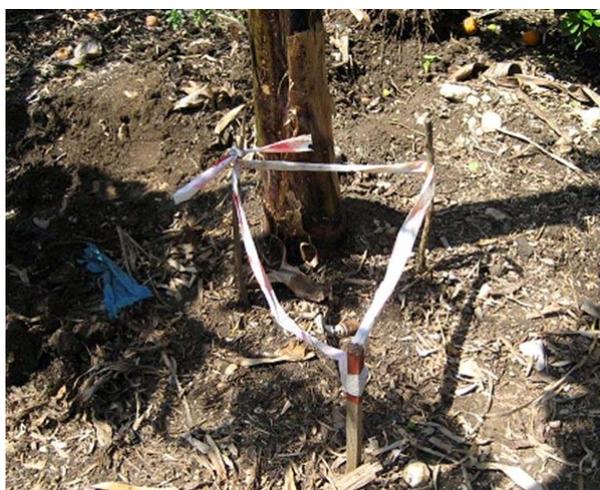
Photograph of Incident Site

The ground was flat, comprising soft soil and covered with banana and orange trees. There was evidence of harvesting and areas had been excavated / cultivated.

The M-77 was on the surface positioned on its side. The submunition was complete with the ribbon attached and some remains of paper tape were attached around the fuze collar. Three wooden pickets and hazardous marking tape were positioned around the item to mark its location.

According to the navigation conducted during the investigation, the M-77 is located to the west and outside task CBU-203 cleared area.

The primary cause of this incident is listed as “Inadequate survey” because the item was found on the boundary of a cleared area, so the hazardous area should have extended further. The secondary cause is listed as a “Management control inadequacy” because the demining group’s perimeter marking had been so poor that it could not be found five months after leaving the site (it is intended to be “permanent”). This made it impossible for the investigators to be certain whether the submunition had been found inside the searched area or not. The use of appropriate marking systems is a management responsibility.

Area reduction should be conducted in the immediate area of the M-77 to confirm whether there are additional submunitions. Surface BAC should be conducted out to a minimum distance of 25 metres from the item creating a 50 x 50 metre (50m²) box and or up to the perimeter of CBU-203 perimeter, whichever, is the greatest. It is recommended that due to the proximity of their current operations, [Demining group] be requested to conduct this.
