DDAS Accident Report

Report date: 12/07/2013	Accident number: 795
Accident time: 09:40	Accident Date: 03/03/2012
Where it occurred: Daphniya Police Station, Zliten	Country: Libya
Primary cause: Other (?)	Secondary cause: Management/control inadequacy (?)
Class: Handling accident	Date of main report: 12/03/2012
ID original source: None	Name of source: LMAC Libya
Organisation: [Name removed]	
Mine/device: Type 84 AT	Ground condition: Ammunition Storage Area demolition site (explosives)
Date record created:	Date last modified: 12/07/2013
No of victims: 1	No of documents: 2

Board of Inquiry Report

[Demining group], Libya (Daphniya)
Fatal Accident - 03 March 2012

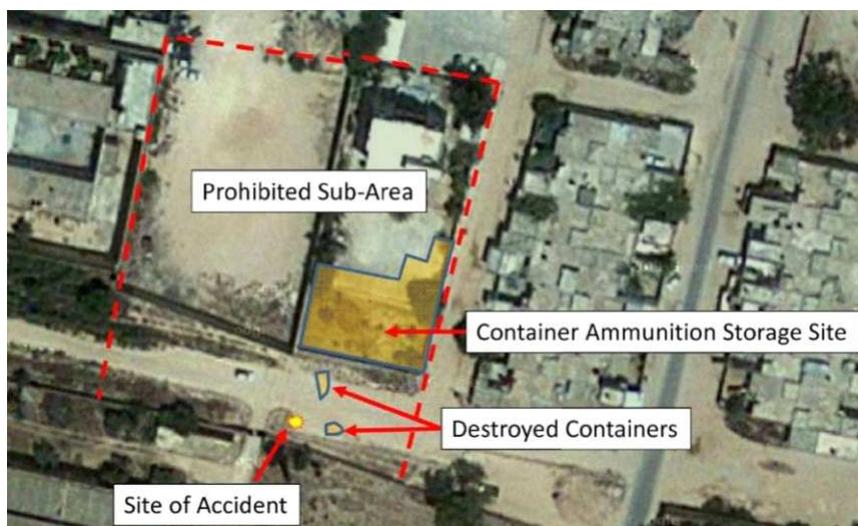
Image 3: Prohibited Sub-Area Overview

The overview below (Image 3) is a close up image of the prohibited sub-area showing key locations.

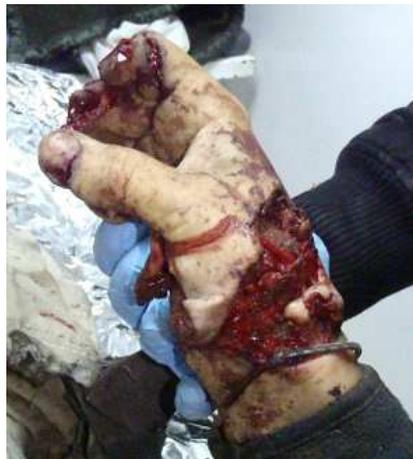
There was a massive traumatic wound to the front left quadrant of the head (M34 and M35); there were no burns or charring. Medical opinion is that this was the cause of death and that life would have expired instantaneously. The injury displays the typical indications of fragmentation injury. Experience of the Board of Inquiry members on past accident investigations suggests that this could possibly be due to the Misnay-Schardin plate being projected at high velocity (4000 – 5000 m/s) from a Type 84 mine; the size of the wound would be conducive with an explosively formed projectile (EFP) from a 118mm diameter warhead. But another source of high velocity fragmentation certainly cannot be excluded on the limited evidence available.

The fingers of the right hand were removed by traumatic amputation (M22); this injury is consistent with high velocity fragmentation damage. The remainder of the right hand and thumb was relatively undamaged (M22). There were no burns or charring to the right hand. The left hand was undamaged (M21).

There was significant blast damage, burning and charring to the lower right leg (M18), suggesting that this was very close to a seat of the explosion on, or just above, the ground. The right arm had suffered high velocity fragmentation injuries just above the elbow (M26).

There were numerous, low velocity fragmentation impacts to the body on the right hand side (M25).

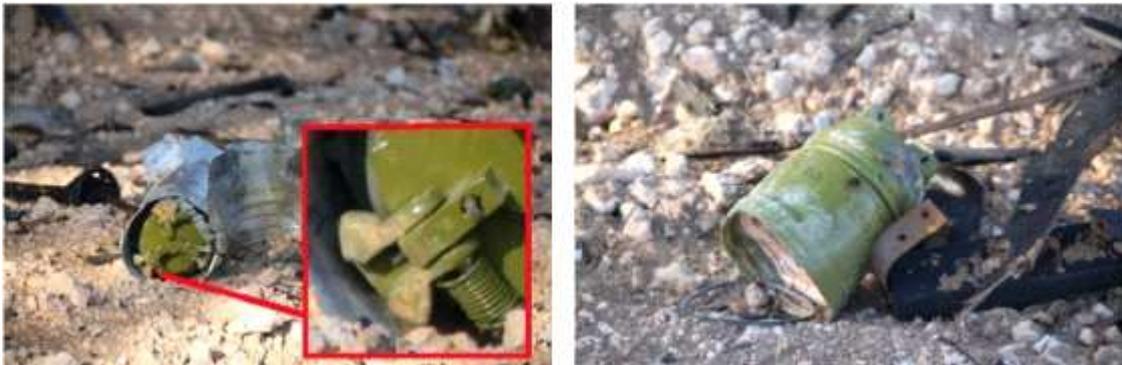
Armed Type 84 mine, still in the broken carrier. condition.

Type 84 mine in unknown, but possibly armed,

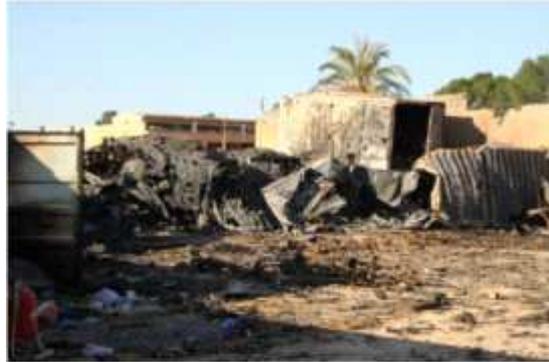
K73 03/03/12 - 09:22
View through the hole in the wall towards the destroyed container area. This is the final picture found on the SD Card.

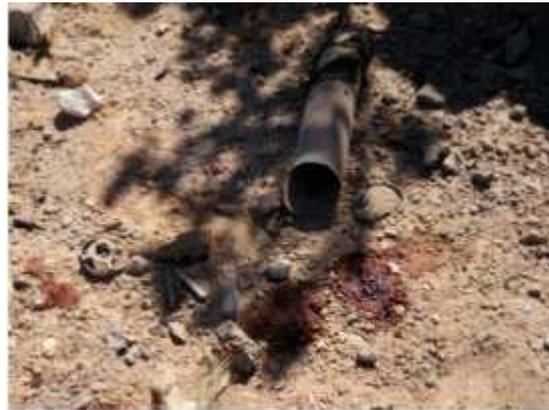
S10 03/03/12
Site of the accident with Leatherman tool and remains of detonated Type 84 mines.

[The investigators noted that the Leatherman was with the bloodstained remains of the detonated mines but did not mention it again.]

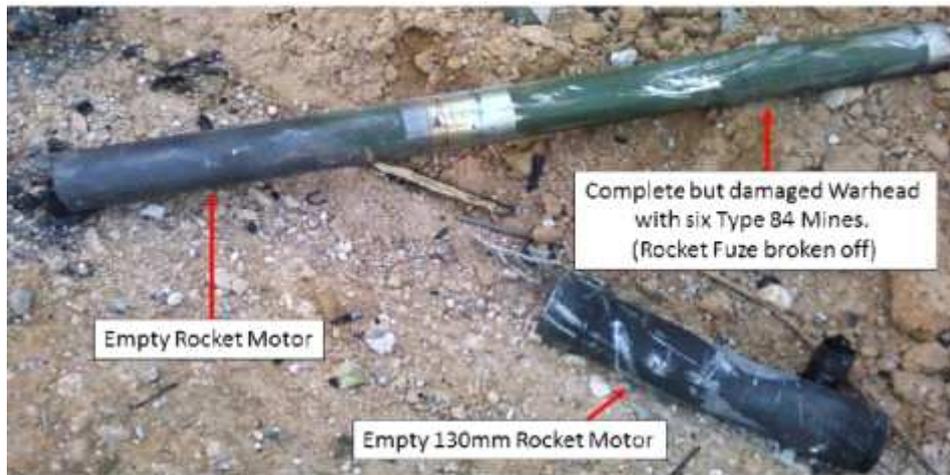
The following photograph was taken by a member of the local community and was handed over anonymously to [Demining group]. The existence of the rocket at the place of the accident was validated through the photographs K60 and S1.

Damaged Chinese 122-15 ATML Rocket suspected to be cause of explosions. The lower right part is an empty 130mm rocket motor, which was accelerated to the opposite wall.

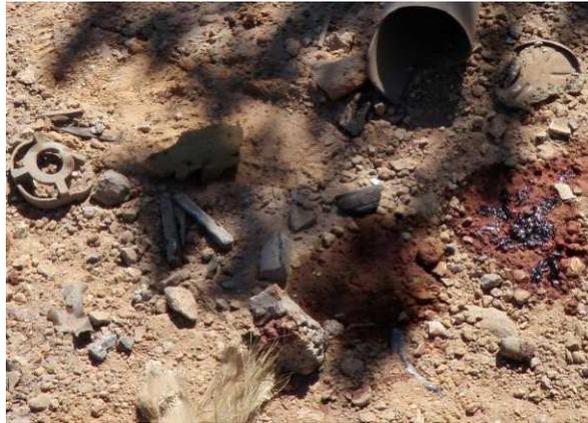
2) The investigators ignored the fact that the Victim of this accident had his leatherman multi-tool at the time. It appears in photographs amid the device debris, stained by blood, but the implication that it was in use at the time was not even considered in the report.

The concern about the susceptibility of the device to initiation by the faint electromagnetic influence of a stainless steel hand tool, his radio or cell phone was made much of. Designed to be initiated by the electrical influences from a large armoured vehicle, this was always extremely unlikely. Subsequent tests conducted by UK Government specialists appear to confirm this. The Demining group management interviewed by the DDAS researcher (shortly after the event) preferred this explanation to the more obvious conclusion that the Victim was deliberately interacting with the device. As the accident record shows, deliberate interaction is a common cause of severe injury and death among highly experienced international staff. Failure to recognise this is not likely to lead to controlling it.
