DDASaccident796

DDAS Accident Report

Internal Demining Group Accident Report

BAC Task N° 01/11/2011. AJDABIYA/ Henaya Military Compound

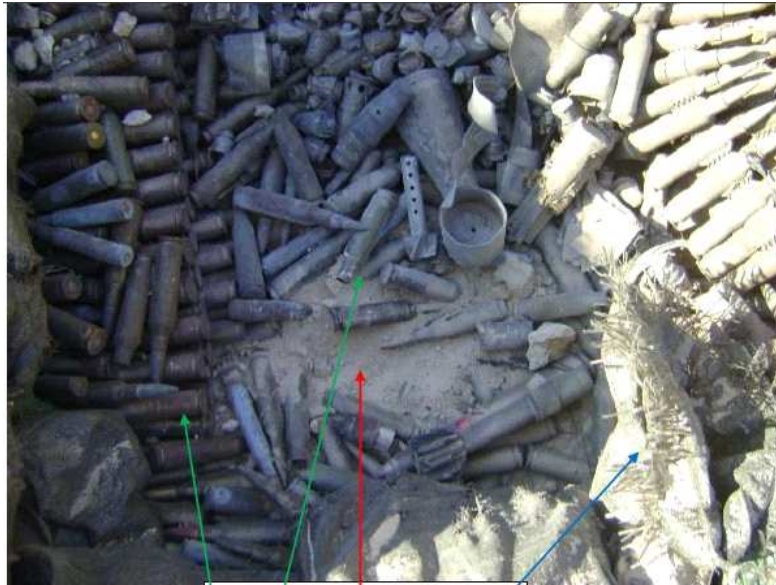
At 10.02 AM, During the transfer of the fuses from Searcher [Victim No.2] to ISS [Victim No.1], one fuse fall on the soil and detonate close to the right foot of the ISS. Injures occurred to small metallic parts of the fuse.

It is suspected that the accident was caused by some flash/spit fuse probably from an artillery projectile, as to how it was activated is probably due to the following:

Detonation point
 Sand bag damaged by the detonation

14,5 mm and parts of ERW kicked and removed out the sand bag by the detonation

The accident record shows that the most common accident with mixed ordnance is with fuzes and that severe eye injury often ensues. The wearing of eye protection while moving ordnance should be a minimum requirement for any responsible demining group concerned to maintain their Duty of care for their employees.

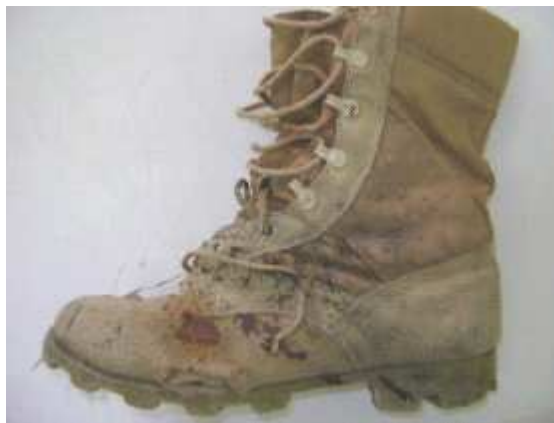
The ISS was injured on several parts of the body (front of the right leg, back of the left one, and face) the most important injury is the right foot.

Right shoe. No evidence of a detonation under the shoe. Evidence of fragmentation hitting this part of the foot.
