### DDASaccident796

# DDAS Accident Report

### Internal Demining Group Accident Report

BAC Task N° 01/11/2011. AJDABIYA/ Henaya Military Compound

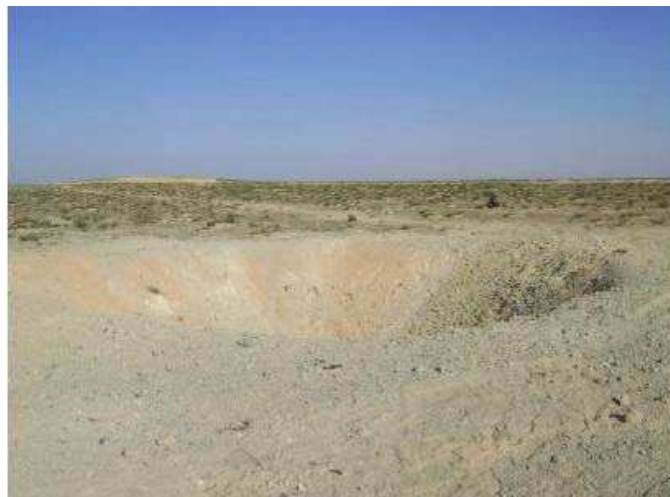
Demolition pit in HYNA area, 9 km East from Ajdabiya

Detonation point  
 Sand bag damaged by the detonation

14,5 mm and parts of ERW kicked and removed out the sand bag by the detonation

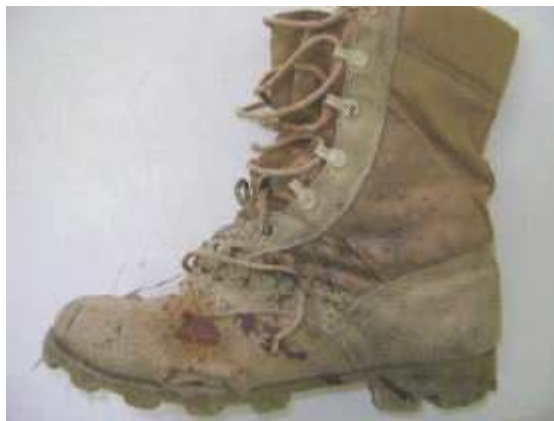
Right shoe. No evidence of a detonation under the shoe. Evidence of fragmentation hitting this part of the foot.
