DDAS Accident Report

JOINT MINE ACTION COORDINATION TEAM
[UNMAS] BENGHAZI REGIONAL OFFICE
REPORT FOR ACCIDENT INVESTIGATION BOARD OF INQUIRY – EAST001/2011

Report on ERW accident that occurred in Ajdabiya at Al-Haniyah ASA on 15th November 2011 in which a [Demining group] Ambulance Driver was injured.

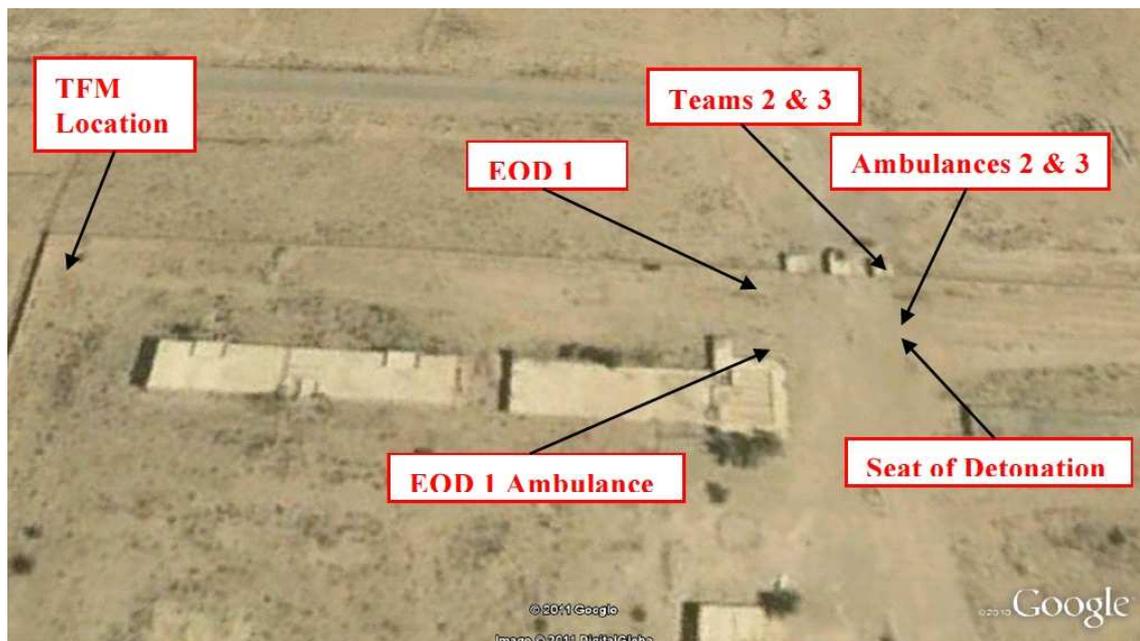
[Accident site]

In the morning of 15th November [Supervisor TFM] arrived with his team (EOD 1) to the ASA at 08:00. After few minutes he received a call from the International Site Supervisor (ISS) Mr. [Name removed] informing him that he is coming with the two new teams to carry out on-job-training for them prior to their deployment in the field. The two teams arrived to the ASA at 08:25. The ISS instructed the two teams to stay inside the rooms at the entrance of the ASA; he also instructed the two ambulance drivers to park inside the ASA. At the moment of the explosion, the locations of different personnel and the three ambulances at the accident scene were as per the "photo 1". [See photo above.]

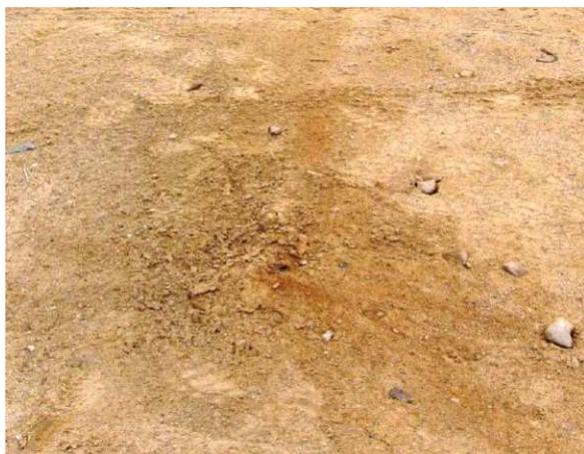
[The 'crater' on a wet sand road. It is a light scar on the ground indicating a very small device near the surface.]

b) There was a surface detonation of the item; evidence shows that the colour of the soil surrounding the seat of detonation changed due to explosives.

It is assessed that the explosive weight of the item in question was no more than a couple of grams, due to the size of the seat of the explosion and the light injuries inflicted. The fragments seen at the seat would also support a light weapon fuse similar to that found in an RPG type weapon.
