# DDASaccident797

# DDAS Accident Report

JOINT MINE ACTION COORDINATION TEAM  
[UNMAS] BENGHAZI REGIONAL OFFICE  
REPORT FOR ACCIDENT INVESTIGATION BOARD OF INQUIRY – EAST001/2011

Report on ERW accident that occurred in Ajdabiya at Al-Haniyah ASA on 15th November 2011 in which a [Demining group] Ambulance Driver was injured.

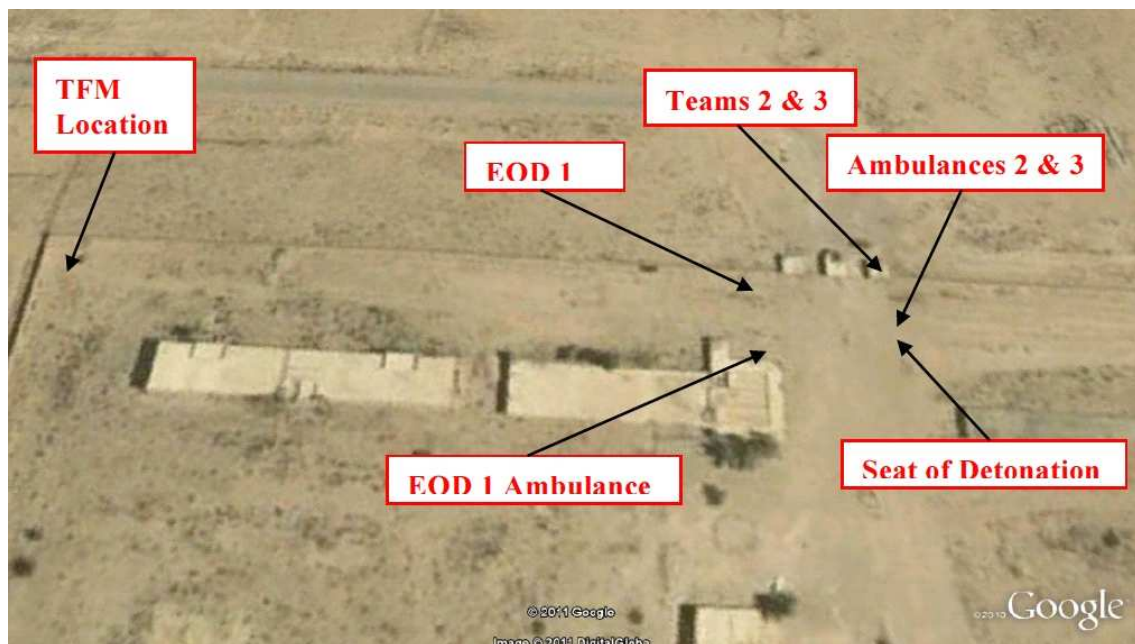
[Accident site]

In the morning of 15th November [Supervisor TFM] arrived with his team (EOD 1) to the ASA at 08:00. After few minutes he received a call from the International Site Supervisor (ISS) Mr. [Name removed] informing him that he is coming with the two new teams to carry out on-job-training for them prior to their deployment in the field. The two teams arrived to the ASA at 08:25. The ISS instructed the two teams to stay inside the rooms at the entrance of the ASA; he also instructed the two ambulance drivers to park inside the ASA. At the moment of the explosion, the locations of different personnel and the three ambulances at the accident scene were as per the "photo 1". [See photo above.]

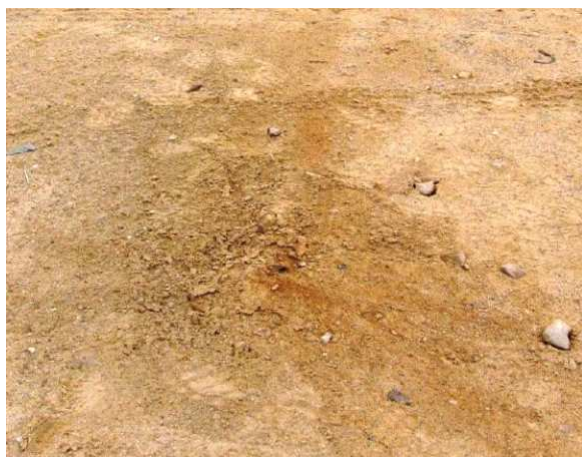
[The 'crater' on a wet sand road. It is a light scar on the ground indicating a very small device near the surface.]

b) There was a surface detonation of the item; evidence shows that the colour of the soil surrounding the seat of detonation changed due to explosives.

It is assessed that the explosive weight of the item in question was no more than a couple of grams, due to the size of the seat of the explosion and the light injuries inflicted. The fragments seen at the seat would also support a light weapon fuse similar to that found in an RPG type weapon.
