DDASaccident800

DDAS Accident Report

Report of the investigation into the circumstances surrounding the demining incident that occurred on 26th May 2008 at Jhalbhanjyang (JBJ) minefield resulting in injury to Sapper [Name removed] of the Nepal Army demining team no.3.

Demining Accident Investigation Report

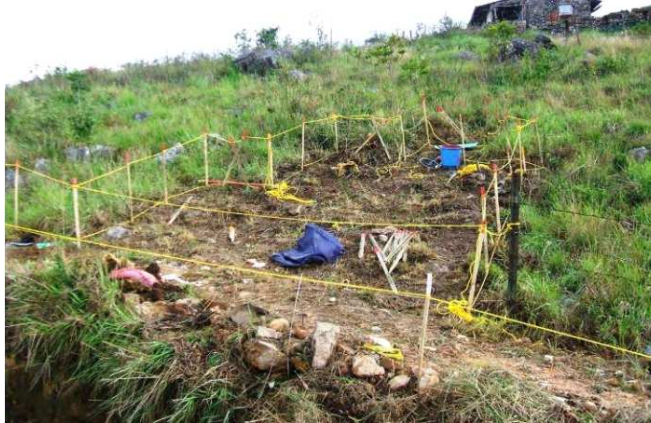
[The accident site]

10. Details of the task being carried out at the time of the incident: QA post-demolitions in Lane No's 1, 3, 4, 5 & 6
11. When and where the incident occurred: At approximately 1630hrs on 26th May 2008 in Lane No 3, Site A

Pte [2nd name removed] was called forward from the Control Point to take over from Pte [the Victim] in Lane No 3. The handover between the two deminers took place in Lane No 3 and both deminers handled the fuze assembly. Pte [2nd name removed] then proceeded to carry out QA post-demolitions on the 2nd blast hole whilst Pte [the Victim] picked up the fuze assembly to take it to the metal collection point; at this point the fuze assembly exploded in his right hand.
