DDASaccident801

DDAS Accident Report

mine/uxo accident and incident detailed investigation report

IMCT 5 Task ID: NR-880 EI Maria, Kassala State

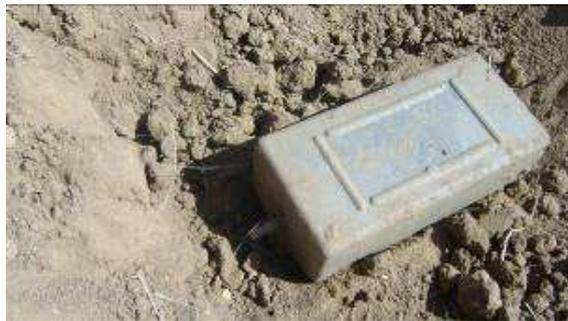
No4 (Iranian) A/P blast mine was involved in the accident.

Explosive content: 155g of TNT and 23g booster charge of PETN/TNT (88/12)

Operating pressure: 8kg

LengthxWidth: 135mm x 65mm

Fuze options: No 9 Igniter similar to MUV type fuzes

The No 4 is actuated by 8 kg of pressure on the upper lid. The force displaces a collar from the fuze. With the collar removed a spring loaded firing pin is free to snap onto the percussion detonator and begin the explosive chain.

4. If the No4 mine is underground you will not know how it is lying when you get the signal from the mine detector and when you start your prodding procedures you might prod on top of the mine or the fuze and that make this mine very dangerous.

3. Once the items has been located, and found to be a mine, only sufficient excavation is to take place to allow positive identification. If, in the case of the signal being a No4 A/P mine, the deminer must approach the mine from the rear.

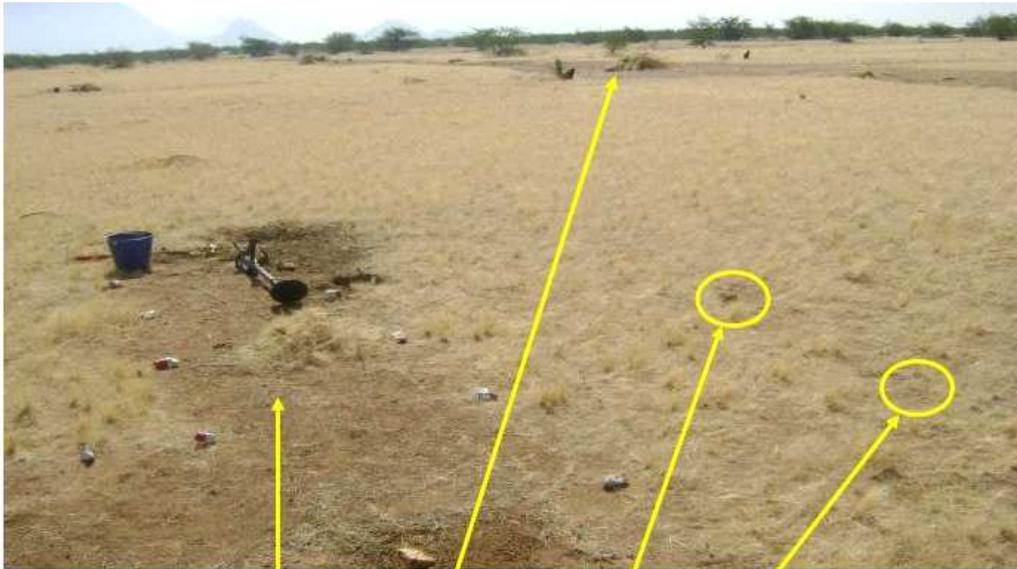
Accident site:

Blast hole was 10cm deep and 40cm across.

Mine-row No 2 Mine-row No 1 Prodder Handle & Prodder

Whilst securing the site the TM noticed the damaged prodder, which had separated at the handle/probe point, had come to rest approximately 10m behind & to the right-side of the deminer in an uncleared area. The end of the prodder was bent at an angle of 30degrees.

The deminer's basestick was broken in two by the blast and three marking stones had also been moved (one by the deminers right arm). The blast hole was 10cm deep and 40cm across (GPS: E36° 35' 41.9" N15° 25' 37.6").

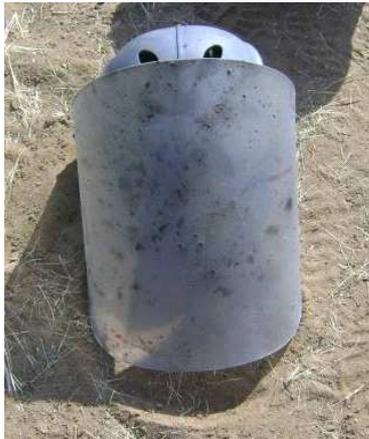
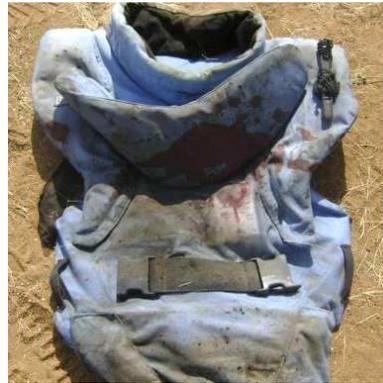
Photographs of PPE & Helmet/Visor damage:

ROFI PPE & LDH Lightweight Demining Helmet/Visor were worn by the deminer slight damage sustained to the PPE jacket and major pock-marking to the Visor.

It is clear from the damage sustained to the deminer PPE & Helmet/Visor that further, more serious injuries, would have occurred without it.
