DDAS Accident Report

Report date: 29/12/2013	Accident number: 802
Accident time: 08:55	Accident Date: 13/04/2011
Where it occurred: IMCT4 NR-928 Rasai, Kassala State	Country: Sudan
Primary cause: Field control inadequacy (?)	Secondary cause: Management/control inadequacy (?)
Class: Missed-mine accident	Date of main report: 14/04/2011
ID original source: None	Name of source: [Removed]
Organisation: [Name removed]	
Mine/device: PRB-M3 AT blast	Ground condition: dry/dusty, hard, metal fragments
Date record created:	Date last modified: 29/12/2013
No of victims: 1	No of documents: 1

Mine/uxo accident and incident detailed investigation report

IMCT4 Task ID: NR-928 Rasai, Kassala State

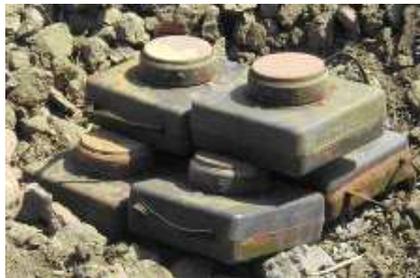
PRB-M3 (Belgium) A/T blast mine was involved in the accident.

The PRB-M3 is a square shaped, plastic bodied, AT mine which is designed to damage or destroy vehicles by blast effect. The mine consists of three parts: the mine body, M30 fuze, and the pressure plate. The mine body has rounded edges and is made of olive coloured plastic; a cloth carrying handle is moulded into the side of the mine body. The pressure plate is circular and is centered on top of the mine body. The mine functions when pressure is applied to the top of the pressure plate. The M30 fuze contains only one gram of metal which makes the PRB-M3 very difficult to locate using metal detectors under most field conditions. Trials have shown that the mine is resistant to sympathetic detonation from other mines. A variant of the mine called the PRB-M3 A1 is identical except that it has two anti-disturbance fuze cavities, one in the side and one in the bottom. Two spring loaded strikers are held apart by a cylindrical hollow bolt which has two perpendicular apertures. The bolt is connected to the pressure protecting cap of the fuze and moves freely along a slide in which there are two percussion caps pressed together. The bolt holds the two strikers apart and covers the percussion caps. When pressure over 250 kg is applied to the pressure plate, shear pins on the plate break and the bolt is displaced, the two apertures align with the percussion caps and release the spring loaded strikers. The strikers hit the percussion caps firing the detonator and the mine.

The PRB M3 is difficult to detect using metal detectors in field conditions where the ground has high metal content or fragmentation is present. In good conditions such as sand the PRB-

M3 can be located using a metal detector. The PRB M30 anti-disturbance device is a separate component which can be used with many mines which is laid underneath the mine. This will detonate if the mine is moved more than 30mm. The PRB-M3 A1 has two anti-disturbance cavities and looks identical to the more common PRB-M3.

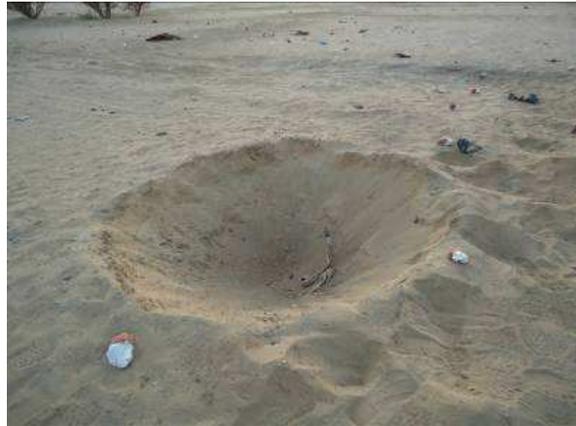
Accident Blast hole:

1. Questioning the witnesses it appears that the GPM Support vehicle drove to the machine to handover the replacement fuze; the vehicle then reversed out back down the 'cleared lane' towards the 'safe area' and veered off this lane into an uncleared area (GPM skip area). The GPM Support vehicle had a mine-strike approximately 1m into the uncleared area. The vehicle was turned around 90° in a clockwise direction and resting approximately 2m away from the seat of the explosion..

4. The mine that was detonated by the vehicle strike was also to the East of the Jebels approximately 50m to the South of the animal strike.
5. The driver was not wearing PPE & Helmet/visor.

Blast hole was 0.7m deep and 2.1m across.

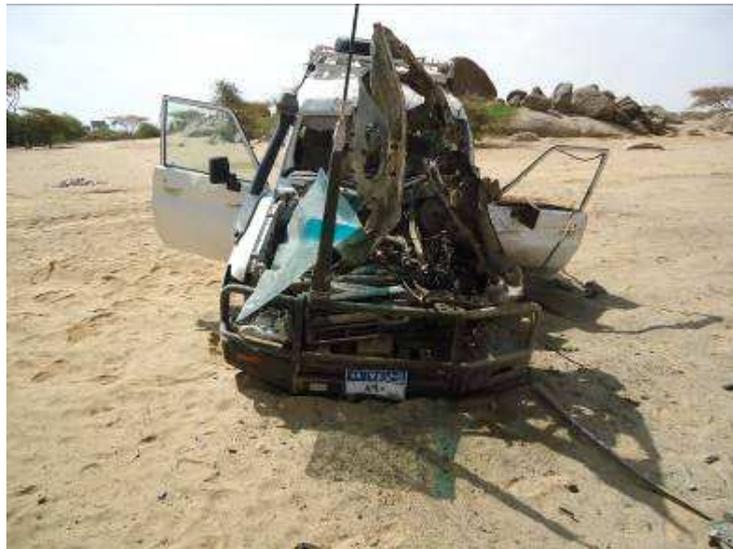
Photograph of LC damage:

LC UN530 was destroyed as a result of the mine-strike

- after successfully delivering the equipment the driver began exiting the area
- whilst leaving the area he strayed into an uncleared area and struck an AT mine with the front left side wheel

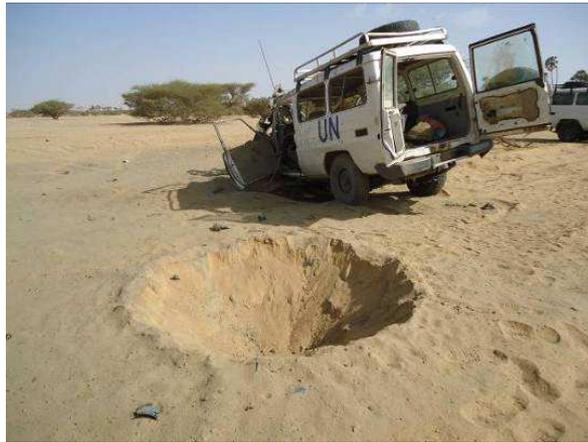
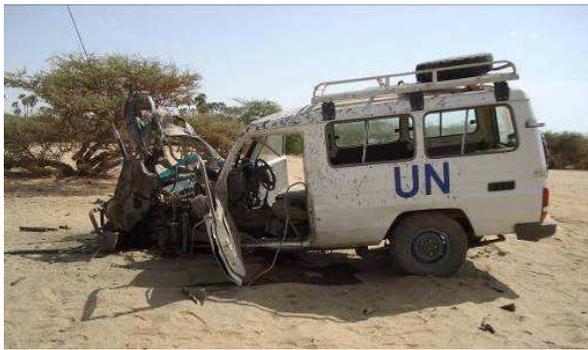
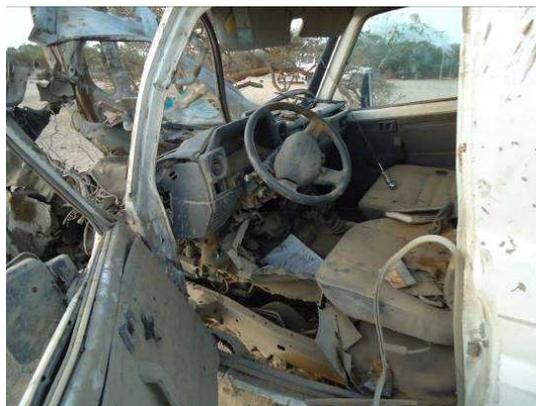
B. LC & Site Pictures [Held on file, many showing no marking in area]

1. The accident site was not laid out as per [Demining group] SOPs (pictures attached).

- The complete site is devoid of any marking and consequently does not conform to [Demining group] SOPs and/or NTSGs.
- The 'clearance lane' leading to the GPM was not marked, therefore no delineation between uncleared and cleared areas could be made.

- Numerous 'skip areas' were noted and these had not been marked as such. The mine-strike was in between two GPM clearance lane in one of the skip areas.

- For some reason only the Northern half of the GPM clearance lane had been MMC(V) cleared; the mine-strike occurred in the area not MMC(V) cleared; however this could not be confirmed due to no minefield marking.

- It is recommended that refresher training takes place to include minefield marking, CASEVAC & Recovery procedures as a minimum.

- It is further recommended that more frequent external visits are conducted by UNMAO/NMAC to ensure all procedures on site are being followed and conducted as per [Demining group] SOPs & NTSGs.
- This accident was avoidable if the basic principles and procedures had been followed on site.
