## DDASaccident802

# DDAS Accident Report

### Mine/uxo accident and incident detailed investigation report

#### IMCT4 Task ID: NR-928 Rasai, Kassala State

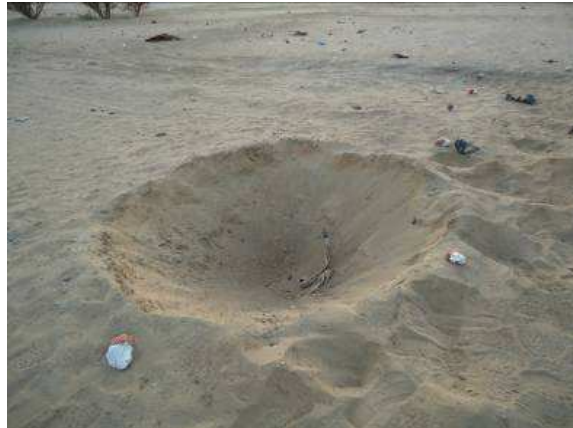
Accident Blast hole:

Blast hole was 0.7m deep and 2.1m across.

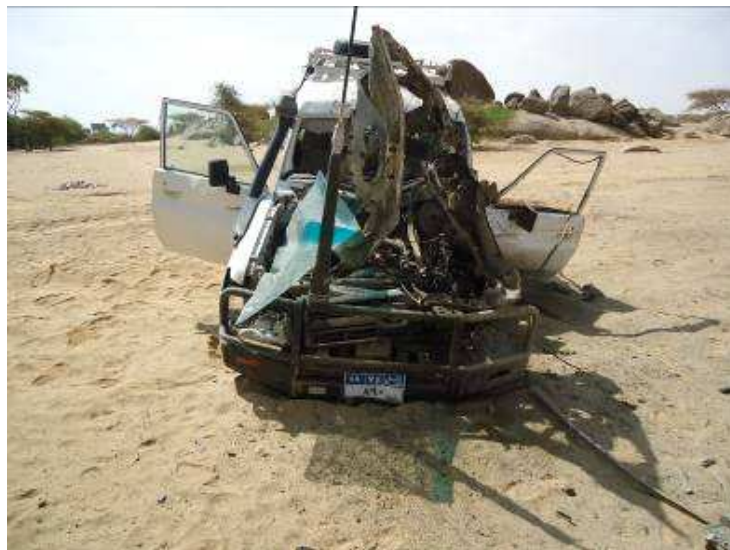
Photograph of LC damage:

LC UN530 was destroyed as a result of the mine-strike

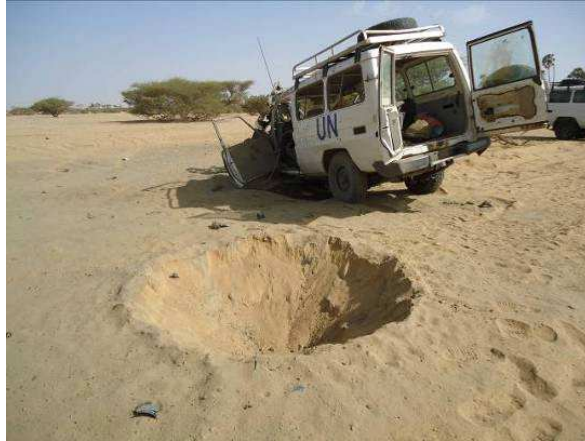
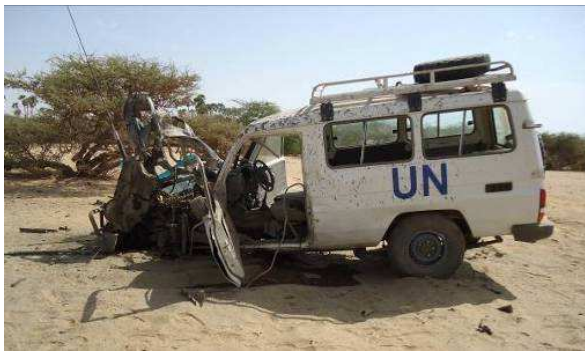
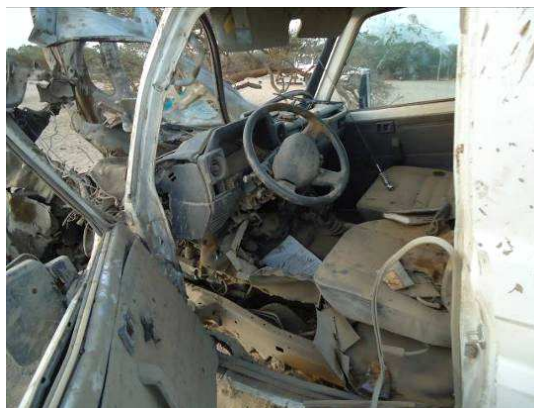
B. LC & Site Pictures [Held on file, many showing no marking in area]

- The casualty was extracted from the vehicle by two deminers via the rear door. It was noticed that there was no clearance marking leading up to the mine-strike vehicle.

- The complete site is devoid of any marking and consequently does not conform to [Demining group] SOPs and/or NTSGs.
- The 'clearance lane' leading to the GPM was not marked, therefore no delineation between uncleared and cleared areas could be made.

- Numerous 'skip areas' were noted and these had not been marked as such. The mine-strike was in between two GPM clearance lane in one of the skip areas.

- It is recommended that refresher training takes place to include minefield marking, CASEVAC & Recovery procedures as a minimum.

- It is further recommended that more frequent external visits are conducted by UNMAO/NMAC to ensure all procedures on site are being followed and conducted as per [Demining group] SOPs & NTSGs.
- This accident was avoidable if the basic principles and procedures had been followed on site.
