DDASaccident803

Humanitarian Demining Accident and Incident Database
AID

DDAS Accident Report

Internal Demining group accident report

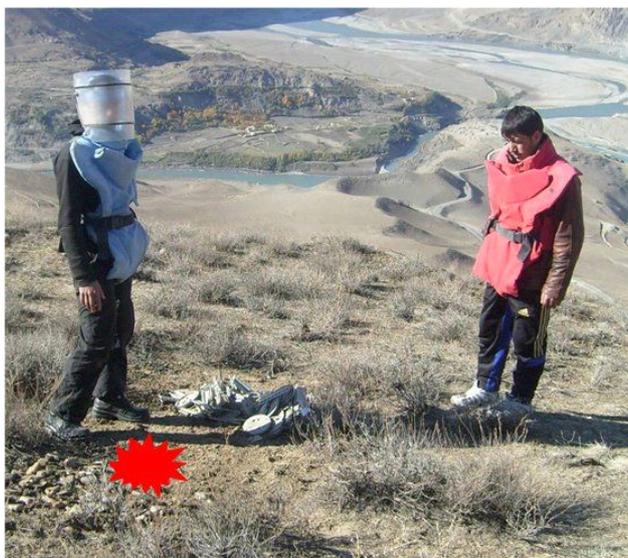
The picture shows the site of the accident. Collected PFM mines and collected scrap (largely from the dispenser) have been collected in an unmarked area that has not been prepared. The munitions have not been placed in an orderly way.

The primary cause of this accident is listed as a "*Management Control Inadequacy*" because the senior international supervisor present had not ensured that the mine collection area was appropriately prepared and marked and was not wearing PPE correctly. The management who had appointed him had not ensured that he knew or would enforce the demining group's own SOPs and basic safety standards. The secondary cause is listed as "*Inadequate training*" because it seems that both supervisors did not understand the dangers of piling live mines in an untidy collection area. It is surprising that only one mine detonated, and it was lucky that Victim No.2 was not struck in the eye by the fragments that struck his face.

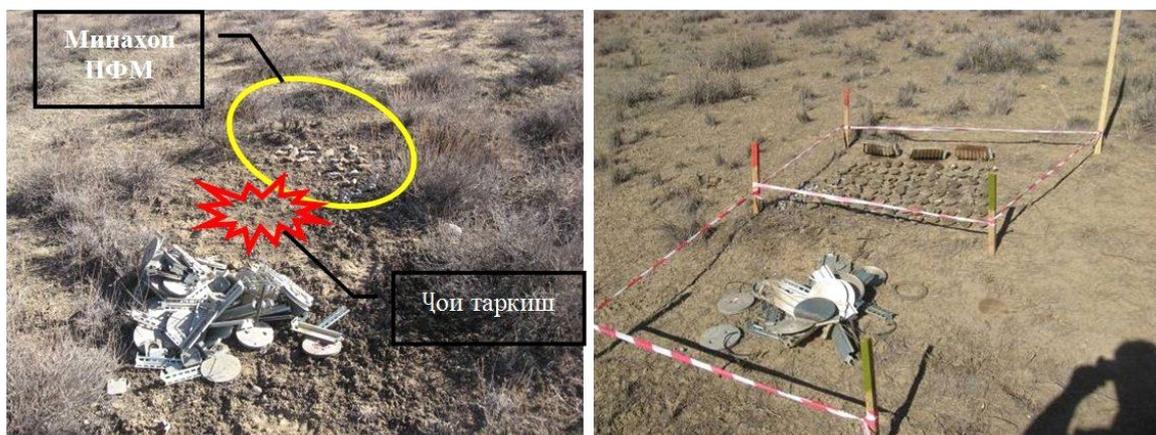
This picture shows what the area looked like before and after the investigation.
