DDASaccident804

Humanitarian Demining Accident and Incident Database
AID

DDAS Accident Report

Report date: 12/08/2016	Accident number: 804
Accident time: 07:17	Accident Date: 01/10/2014
Where it occurred: Mf: #96, Qomsangir District, Khatlon region	Country: Tajikistan
Primary cause: Unavoidable (?)	Secondary cause: Inadequate training (?)
Class: Excavation accident	Date of main report: 09/10/2014
ID original source:	Name of source: Demining group
Organisation: [Name removed]	Ground condition: dry/dusty; steep slope
Mine/device: PMN-2 AP blast	Date last modified: 12/08/2016
Date record created:	No of documents: 3
No of victims: 1

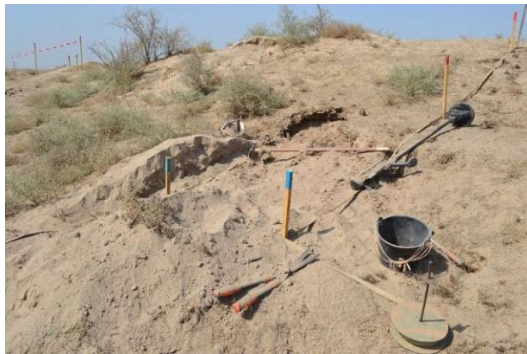
Place of accident

The accident occurred in the minefield, inside deminers working lane, during excavation drills.

Deminer's working lane (13m) was the closest one to control point. Area from the right side of deminer's line was cleared and marked in accordance to SOP. Sampling of this cleared part of the minefield was conducted by TL and TS a couple of days before accident.

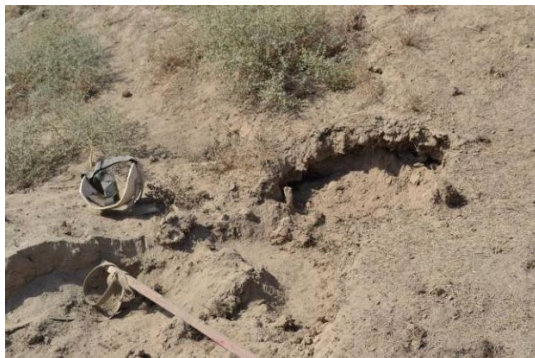
Crater

Hole of detonation was discovered some 50cm behind base stick.

Diameter of the hole was 70cm with a depth of more than 30cm.

Detonation didn't produce typical cone shape crater but almost flat surface.

Surface layer of the ground collapsed at the place of detonation and filled empty space in the hole.

Some pieces of fragments of PMN2 mine were found in the explosion hole.

According to shape of the mine explosion hole, its size, and depth of fine-grained, loose and dry soil in the hole, it is obvious that mine was not in original normal position, but most likely turned upside down.

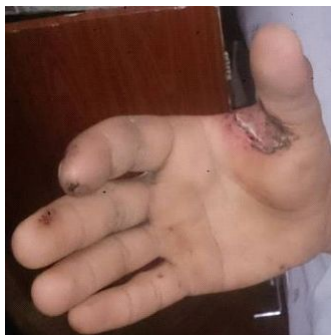
Casualty's right hand.
