DDASaccident804

Humanitarian Demining Accident and Incident Database

DDAS Accident Report

Report date: 12/08/2016	Accident number: 804
Accident time: 07:17	Accident Date: 01/10/2014
Where it occurred: Mf: #96, Qomsangir District, Khatlon region	Country: Tajikistan
Primary cause: Unavoidable (?)	Secondary cause: Inadequate training (?)
Class: Excavation accident	Date of main report: 09/10/2014
ID original source:	Name of source: Demining group
Organisation: [Name removed]	Ground condition: dry/dusty; steep slope
Mine/device: PMN-2 AP blast	Date last modified: 12/08/2016
Date record created:	No of documents: 3
No of victims: 1

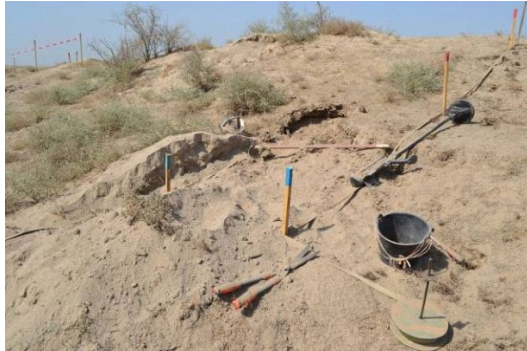
The accident occurred in the minefield, inside deminers working lane, during excavation drills. Deminer's working lane (13m) was the closest one to control point. Area from the right side of deminer's line was cleared and marked in accordance to SOP. Sampling of this cleared part of the minefield was conducted by TL and TS a couple of days before accident.

Place of accident

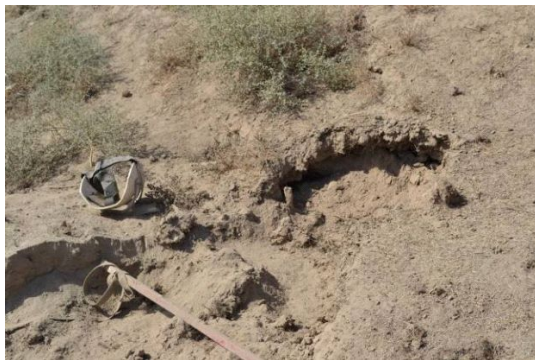
Hole of detonation was discovered some 50cm behind base stick.

Diameter of the hole was 70cm with a depth of more than 30cm.

Detonation didn't produce typical cone shape crater but almost flat surface.

Surface layer of the ground collapsed at the place of detonation and filled empty space in the hole.

Crater

According to shape of the mine explosion hole, its size, and depth of fine-grained, loose and dry soil in the hole, it is obvious that mine was not in original normal position, but most likely turned upside down.

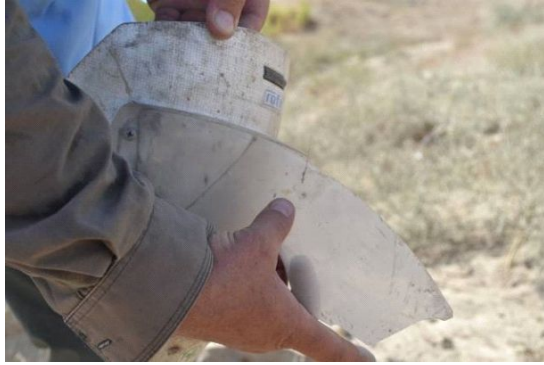
Part of face mask that protects jowl has signs of couple fragments with readable direction of fragments and anticipated blast wave.

First layer of the visor protection layer film was damaged and has a sign of fragment scratch.

Right side of face mask is covered by smoke-black soot.

Face mask.

The loss of the mask during the event is a cause for concern, especially because the Victim's forehead was severely damaged by fragments that could have blinded him had they struck a few centimetres lower. The damage extends across the forehead, down his left cheek and across his chin so it appears that the mask was not present when the fragments struck. The marks appear to have been caused by unburned TNT (common).

In discussion with the demining group it was agreed that either the mask design allows fragments to enter or the mask was not being worn at the time of the accident: If it were in the deminer's hand, that would explain the damage it sustained. If the mask was worn properly and still allowed this much facial damage, the mask would be inappropriate for use when excavating mines. The demining group asked the manufacturer to conduct tests on the mask's performance in an AP mine blast. The testing was carried out by independent specialists in Croatia in 2016 and it was found that the mask performed appropriately, from which it can be reliably inferred that the Victim in this accident was not wearing the mask.

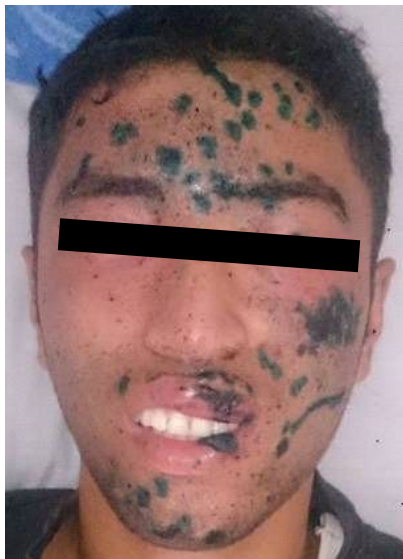
Minor Injuries: Majority of injuries are skin scratches on left side of casualty's face; Dust and dirt in both eyes.; Lightly ragged upper lip from left side and small left eyelid bruise; Shallow cut of skin between thumb and forefinger on right hand.

Casualty's face

It is probable that the mine was undisturbed in the ground beneath the loose spoil left by "rats". The injuries to the deminer and the face-mask imply that his face was over the blast at the time. The severity of his injuries to his eyes – and possible long-term loss of sight – is uncertain.

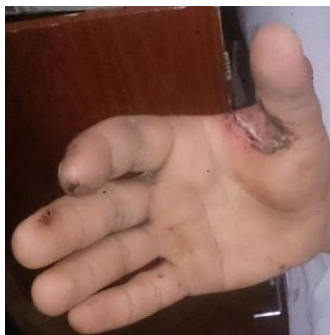
Casualty's right hand.
