DDASaccident805

DDAS Accident Report

Report date: 14/11/2013	Accident number: 805
Accident time: 11:00	Accident Date: 05/03/2013
Where it occurred: Maquetela Task, Maxixe Town, Inhambane Province	Country: Mozambique
Primary cause: Field control inadequacy (?)	Secondary cause: Field control inadequacy (?)
Class: Missed-mine accident	Date of main report: 26/03/2013
ID original source: PH	Name of source: {Demining group}
Organisation: [Name removed]	
Mine/device: PMN AP blast	Ground condition: bushes/scrub dense vegetation metal scrap soft
Date record created:	Date last modified: 14/11/2013
No of victims: 3	No of documents: 1

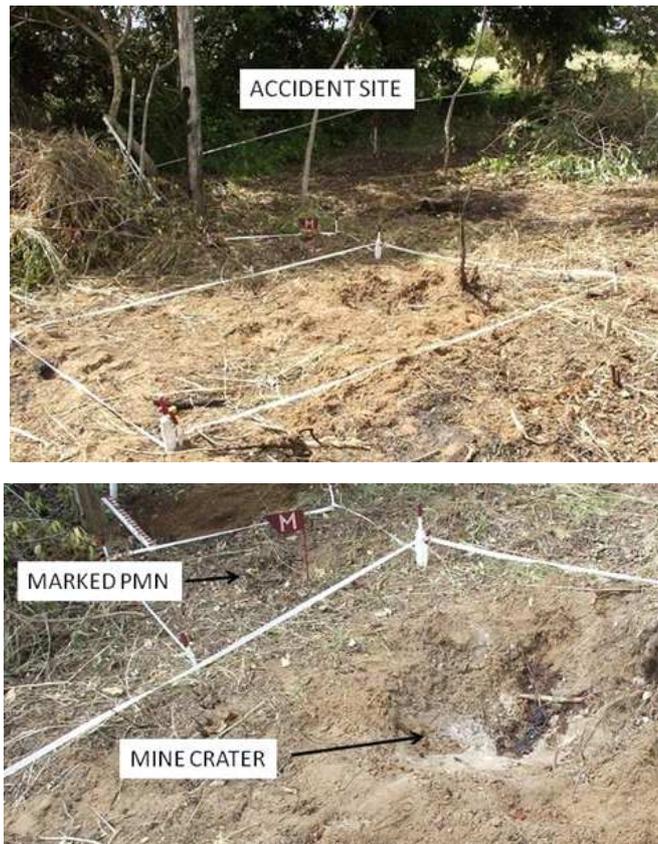
The scene of the accident was divided into two taped off areas. The accident scene (photo A1 [below]), containing the mine crater was marked by an approximately 2m x 2m taped box with a smaller - approximately .5m x .5m - taped box, in which was contained the marked PMN (photos A2 & A3 [held on file]). There was no other demarcation tape present or, oddly, evidence of safe lane marking present. A barbed wire fence runs through the work area (photo A4 [held on file]); however in some places (yet uncleared) only portions of the barbed wire remain.

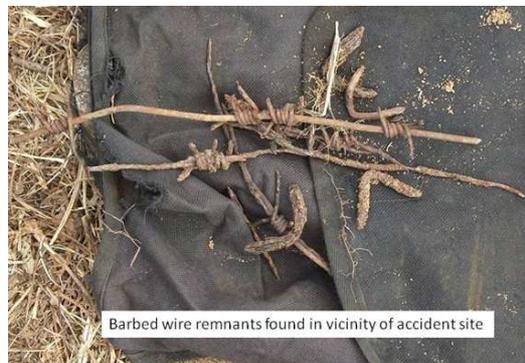
A shallow PMN generally has a large metal-detector signature so is not normally "missed" with a modern metal detector. The lack of marking leaves some uncertainty over whether the area had been detector searched. Presuming that it was, the area was strewn with metal fragments (shown in a photograph) so the deminer may have been ignoring signals smaller than the OZM-72, which has a very large signature.

The presence of a lot of metal fragments (including barbed wire) in the vicinity implies that both the deminer and the Team Leader conducting QA on his work were ignoring signatures smaller than the anticipated mine. This is not uncommon when there is complete confidence that there are only hazards with a large metal signature present. However, the Field supervisor should have known that it is normal practice to protect bounding fragmentation mines with AP blast mines and so have ensured that all metal was recovered until the type(s) of AP blast mine present had been identified. Given the size of a PMN signal, some small metal fragments could then have been safely left. All the fragments shown in the photograph

are ferrous, so the use of a hand-held magnet could have accelerated clearance dramatically (see http://www.nolandmines.com/magnets_for_fragment_reduction.htm).
