# DDASaccident805

# DDAS Accident Report

<b>Report date:</b> 14/11/2013	<b>Accident number:</b> 805
<b>Accident time:</b> 11:00	<b>Accident Date:</b> 05/03/2013
<b>Where it occurred:</b> Maquetela Task, Maxixe Town, Inhambane Province	<b>Country:</b> Mozambique
<b>Primary cause:</b> Field control inadequacy (?)	<b>Secondary cause:</b> Field control inadequacy (?)
<b>Class:</b> Missed-mine accident	<b>Date of main report:</b> 26/03/2013
<b>ID original source:</b> PH	<b>Name of source:</b> {Demining group}
<b>Organisation:</b> [Name removed]	
<b>Mine/device:</b> PMN AP blast	<b>Ground condition:</b> bushes/scrub dense vegetation metal scrap soft
<b>Date record created:</b>	<b>Date last modified:</b> 14/11/2013
<b>No of victims:</b> 3	<b>No of documents:</b> 1

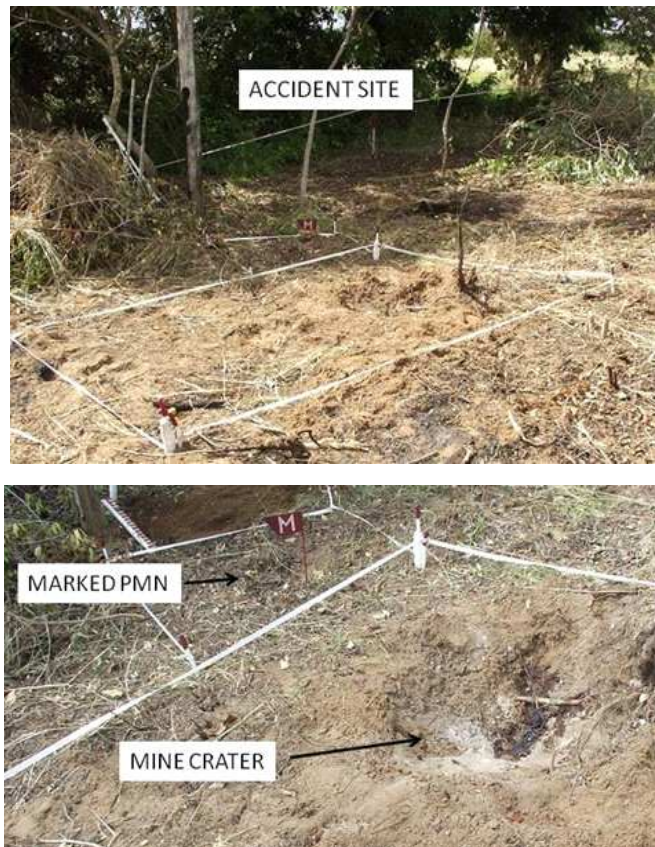
Whilst the Team leader was at the CP reporting the find, the three deminers – [Victim No.1], [Victim No.2] and [Victim No.3] - moved from their lanes to view the PMN. It was at this stage that [Victim No.1] stepped on the missed PMN. The missed mine was located approximately 1.5 metres from the marked PMN.

The scene of the accident was divided into two taped off areas. The accident scene (photo A1 [below]), containing the mine crater was marked by an approximately 2m x 2m taped box with a smaller - approximately .5m x .5m - taped box, in which was contained the marked PMN (photos A2 & A3 [held on file]). There was no other demarcation tape present or, oddly, evidence of safe lane marking present. A barbed wire fence runs through the work area (photo A4 [held on file]); however in some places (yet uncleared) only portions of the barbed wire remain.

The accident occurred when [Victim No.1] stood on a mine not detected by [Name removed A], which was located close to the mine they went to see.

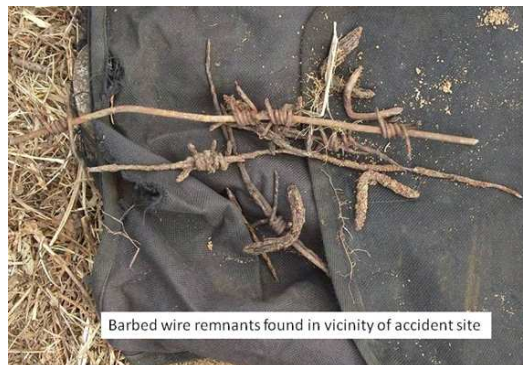
A shallow PMN generally has a large metal-detector signature so is not normally "missed" with a modern metal detector. The lack of marking leaves some uncertainty over whether the area had been detector searched. Presuming that it was, the area was strewn with metal fragments (shown in a photograph) so the deminer may have been ignoring signals smaller than the OZM-72, which has a very large signature.

The presence of a lot of metal fragments (including barbed wire) in the vicinity implies that both the deminer and the Team Leader conducting QA on his work were ignoring signatures smaller than the anticipated mine. This is not uncommon when there is complete confidence that there are only hazards with a large metal signature present. However, the Field supervisor should have known that it is normal practice to protect bounding fragmentation mines with AP blast mines and so have ensured that all metal was recovered until the type(s) of AP blast mine present had been identified. Given the size of a PMN signal, some small metal fragments could then have been safely left. All the fragments shown in the photograph

are ferrous, so the use of a hand-held magnet could have accelerated clearance dramatically (see [http://www.nolandmines.com/magnets\\_for\\_fragment\\_reduction.htm](http://www.nolandmines.com/magnets_for_fragment_reduction.htm)).
