# DDASaccident806

# DDAS Accident Report

<b>Report date:</b> 13/08/2016	<b>Accident number:</b> 806
<b>Accident time:</b> 08:51	<b>Accident Date:</b> 06/06/2015
<b>Where it occurred:</b> MF2, Border post 7, Khoshima, Shoh Village, Qubodiyon District, Khatlon Region	<b>Country:</b> Tajikistan
<b>Primary cause:</b> Unavoidable (?)	<b>Secondary cause:</b> Management/control inadequacy (?)
<b>Class:</b> Excavation accident	<b>Date of main report:</b> 10/06/2015
<b>ID original source:</b>	<b>Name of source:</b> TNMAC
<b>Organisation:</b> [Name removed]	<b>Ground condition:</b> dry/dusty; hard
<b>Mine/device:</b> PMN AP blast	<b>Date last modified:</b> 13/08/2016
<b>Date record created:</b>	<b>No of documents:</b> 2
<b>No of victims:</b> 1

Internal Investigation Report on mine accident in mine field-2 Khoshima, Qubodiyon Distruct, on 06 June 2015. The investigation was conducted by the [Demining group] Head of Operations [Name removed] and Technical Operational Adviser [Name removed].

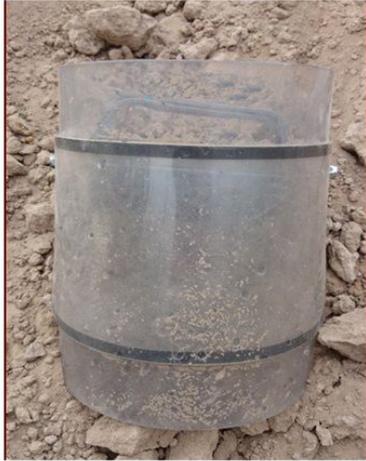
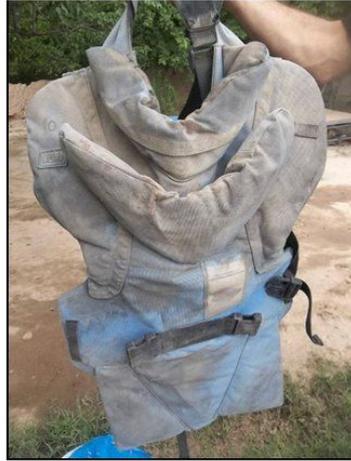
- Protection Visor: at the time of the accident filled with dust and soil.
- Uniform protection: at the time of the explosion was covered with black sand and blood. [See pictures below.]
- Trousers: after the explosion was torn.

[Visor showing a light mud spray and water droplets, but no damage. Frontal armour showing mud on right thigh and all over upper chest. ]

The primary cause of this accident is listed as a “*Unavoidable*” because the investigators thought it likely that loose but heavy material from higher up the slope fell as the deminer was working, and this detonated the mine. This could have occurred. The secondary cause is listed as a “*Management Control Inadequacy*” because the senior demining group staff who investigated the accident were either attempting to conceal a field management failure or were entirely ignorant of the properties of a protective blast visor. The blast visor is permanently curved in one plane so that it wraps around the face. To curve in the opposite plane it would have to split. In a blast event, its existing curve may flatten out slightly and spring back, so demonstrating the elastic properties of polycarbonate, but it cannot bend backwards in the middle without splitting (which it can only do if enough force is applied – a force far greater than the force of an AP blast mine detonation at 60 cm). To have struck the Victim’s mouth and lips with a force hard enough to remove teeth the visor would have had to have flattened and crushed the wearer’s nose further back than his teeth, which it did not (and has never done in any recorded accident).

The unrecorded (but photographed) damage to the Victim’s eye (which appears “normal” in his ID card photograph) may have been caused by sand sucked into the post-blast low-pressure area (a common occurrence) and so does not provide evidence that the visor was not worn before the blast. However, the injury to chin and mouth could not have been inflicted with the visor worn correctly unless the visor had split into separate parts. The visor was undamaged. These facts make it safe to infer that the visor was not worn or not worn in a down position at the time of the accident. The internal investigators appear to have been concealing the breach of SOPs involved in not wearing the visor correctly.

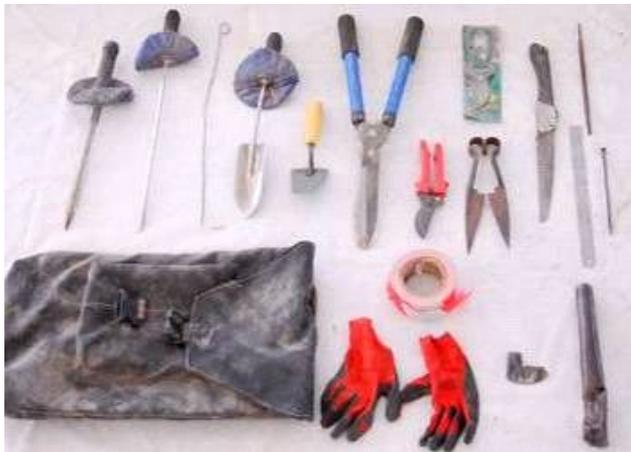
Demining equipment for excavation [Picture included does not show the short tool used at the time of the accident.]

From the photographic evidence, it is clear that the Victim’s small and short trowel (called a shovel in the report) was damaged. It is likely that the tool was in his hand at the time of the accident and thrown backwards by the blast. The back of the flat blade may have struck the deminer on the chin and mouth, knocking out his teeth. The mud stains on the body armour show that the force of the blast appears to have struck his upper body and the investigators report him having been thrown back six metres (a very unusual distance). If this is so, it implies that he was leaning over the top of the explosion but this may not indicate that he was working incorrectly if the blast were caused by a heavy fall of material from above.

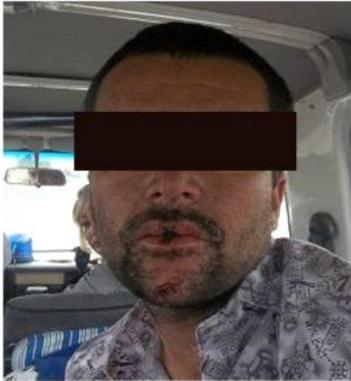
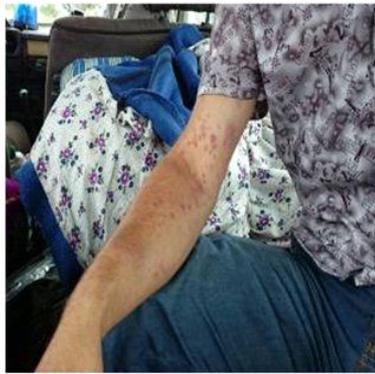
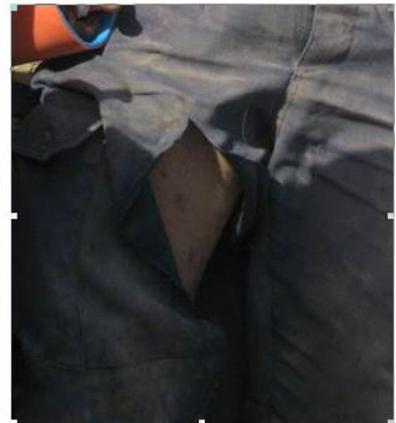
- Small wound on the lips.
- A small wound on the bottom lips.
- Small wound under his chin.
- Sores get small pieces.
- Three front tooth broken.
- Light concussion
- [A possible lung injury is reported in the statements. Eye, arm and leg injury is shown in the photographs.]

Injured picture of [The victim]. [Picture shows left eye slightly puffed and red, lips and chin both split. No damage at all to nose. Other pictures show light fragmentation on right arm from wrist extending over elbow and upper right thigh.]

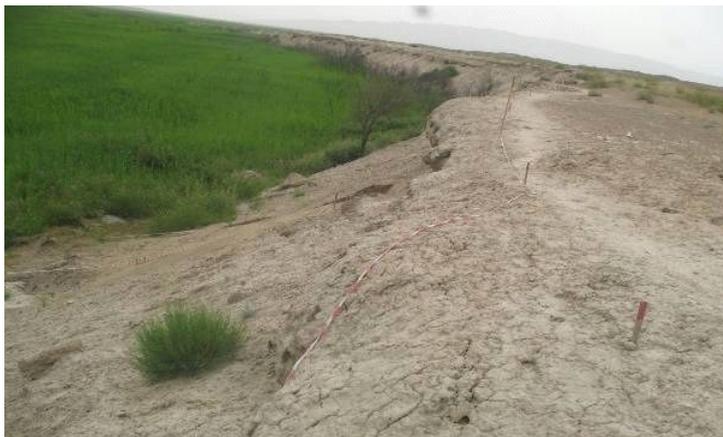
This minefield is situated near observation border point #7 Khoshima. One part of this minefield is laid on an earth ridge of high ground and the lower part is in a reedy area. Due to the location of mines which lie on the crumbling edge of the ridge, the mines have been covered by soil. The depth of these mines is 50-80 cm. For this reason we applied a full excavation method until finding the real minefield area. According to submitted reports from the group in May 2014, in one working day 48.5 m<sup>2</sup> of land was cleared. Due to this reason the work was running very slow in that minefield.

Minefield area on the slippage.

- After destruction of the mines and UXO, the team and section leader should check the place of the destruction.
- This minefield presents challenges to the operation of the de-miners and has a very high risk. It is requested from TMAC use other mine clearance operations, probably mechanical.
