### DDASaccident807

# DDAS Accident Report

<b>Report date:</b> 13/08/2016	<b>Accident number:</b> 807
<b>Accident time:</b> 10:52	<b>Accident Date:</b> 10/07/2015
<b>Where it occurred:</b> MF: HZTJ99 MF6, Sagirdasht Sub- district, Darvaz, Gorno- Badakhshan Autonomous (GBAO) Region	<b>Country:</b> Tajikistan
<b>Primary cause:</b> Field control inadequacy (?)	<b>Secondary cause:</b> Management/control inadequacy (?)
<b>Class:</b> Excavation accident	<b>Date of main report:</b> 11/08/2015
<b>ID original source:</b>	<b>Name of source:</b> Demining group
<b>Organisation:</b> [Name removed]	<b>Ground condition:</b> dry/dusty; grass/grazing area; soft
<b>Mine/device:</b> PMN AP blast	<b>Date last modified:</b> 13/08/2016
<b>Date record created:</b>	<b>No of documents:</b> 2
<b>No of victims:</b> 2

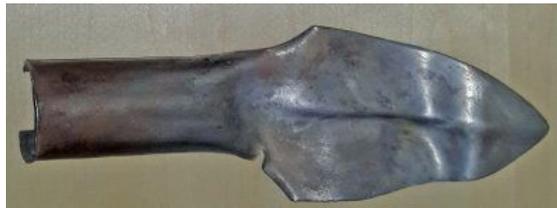
Warped shovel without handle was found 35m away from explosion hole.

[An unclear photograph showing the remains of the “shovel” that was recovered 35 metres away is held on file. The “shovel” is a small trowel made using a single sheet of steel that is curved at one end to form a handle.]
