DDAS Accident Report

Report date: 13/08/2016	Accident number: 807
Accident time: 10:52	Accident Date: 10/07/2015
Where it occurred: MF: HZTJ99 MF6, Sagirdasht Sub- district, Darvaz, Gorno- Badakhshan Autonomous (GBAO) Region	Country: Tajikistan
Primary cause: Field control inadequacy (?)	Secondary cause: Management/control inadequacy (?)
Class: Excavation accident	Date of main report: 11/08/2015
ID original source:	Name of source: Demining group
Organisation: [Name removed]	Ground condition: dry/dusty; grass/grazing area; soft
Mine/device: PMN AP blast	Date last modified: 13/08/2016
Date record created:	No of documents: 2
No of victims: 2

Accident report

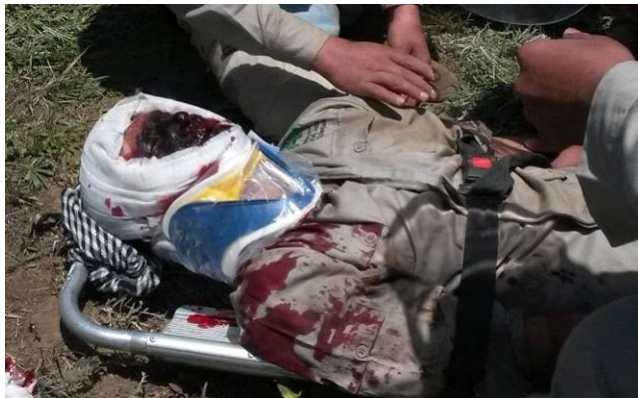
Casualty was delivered from uncleared to safe area less than 01 minute after explosion occurred.
