DDASaccident808

DDAS Accident Report

Report date: 13/08/2016	Accident number: 808
Accident time: 08:10	Accident Date: 12/10/2010
Where it occurred: MF No.2, Archamazor Kevron village, Darvoz district	Country: Tajikistan
Primary cause: Field control inadequacy (?)	Secondary cause: Victim inattention (?)
Class: Excavation accident	Date of main report: Not recorded
ID original source:	Name of source: TNMAC
Organisation: [Name removed]	Ground condition: hard; rocks/stones; steep slope
Mine/device: PMA-2 AP blast and ML-7	Date last modified: 13/08/2016
Date record created:	No of documents: 1
No of victims: 1

MINE ACCIDENT AREA IN THE MINEFIELD OF ARJAI MAZOR (KEVRON), N. DARVOZ EXPLOSION

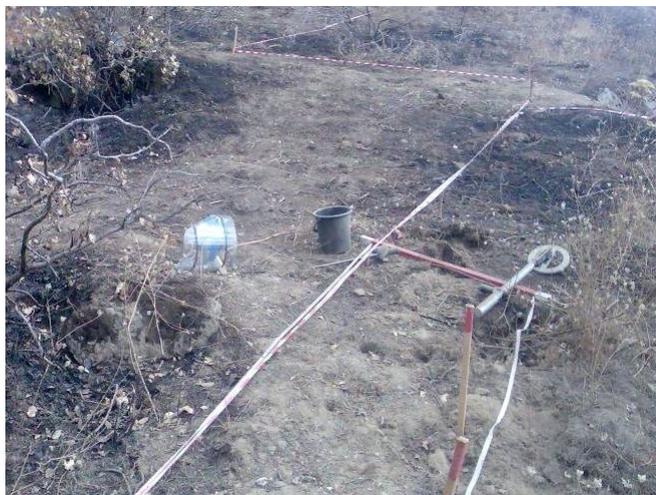
Investigation in the explosion area

Visor located 1,5 m from the accident place at 3000

Basestick located 40 cm from the accident place

Detector located 35 cm from the accident place

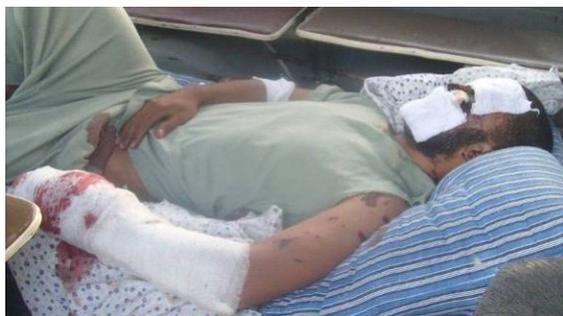
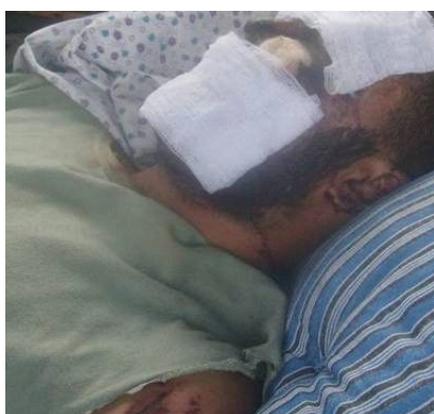
No formal medical report was made available. Photographs show injuries to the left hand and arm, also injuries to the face with dressings over the eyes, nose and mouth and a deep cut on the left shoulder.

In a telephone interview in November 2015 the Team Leader reported that the victim lost one eye completely and lost 70% of the vision in the other. He also lost one entire finger and has severe damage to others.

The Victim's left hand was injured and a broken trowel was shown in photographs. The victim's hand tool included a handguard which was not shown in the photographs. The injuries to his left hand and arm imply that he was using two hands on the tool, with the right gripping the trowel handle and the left pushing on the blade (often seen). Unfortunately it is not recorded whether the Victim is left or right handed.
