DDASaccident809

DDAS Accident Report

Report date: 13/08/2016	Accident number: 809
Accident time: 11:00	Accident Date: 13/11/2013
Where it occurred: Zulu Range, Camp Pembleton, San Diego County, California	Country: USA
Primary cause: Victim inattention (?)	Secondary cause: Management/control inadequacy (?)
Class: Handling accident	Date of main report: 14/11/2013
ID original source:	Name of source: Press
Organisation: [Name removed]	Ground condition: demolition site (explosives)
Mine/device: grenade	Date last modified: 13/08/2016
Date record created:	No of documents: 1
No of victims: 7

Two Marines relieved over Pendleton explosion that killed four

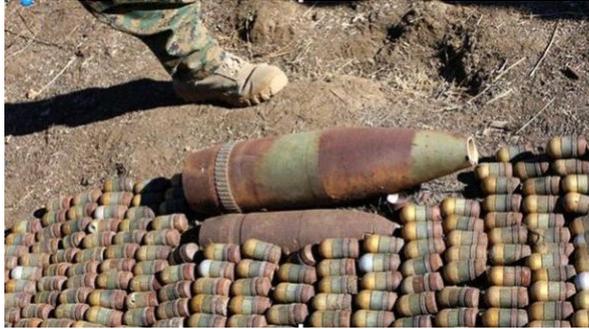
[Picture of actual ordnance involved in the accident.]

A grenade round that was 'dropped, kicked, or bumped' caused an explosion among these 350 grenade rounds and two larger shells, killing four Marines during a Nov. 13 training exercise at Camp Pendleton. The fatal explosion occurred just minutes after this picture was taken. The grenades and shells were being collected from an impact area for disposal.

The primary cause of this accident is listed as "Victim inattention" because the investigation concluded that it was likely that one of the victims dropped or kicked a grenade and started the explosive event. It is possible that a grenade was dropped while being passed from hand to hand. The secondary cause is listed as a "Management control inadequacy" because the investigation led to two senior officers being suspended for failure to ensure that safe practices were conducted during the activities.
