DDASaccident810

DDAS Accident Report

Report date: 25/08/2016	Accident number: 810
Accident time: 08:20	Accident Date: 01/09/2008
Where it occurred: Sagirdash village, Darvoz District, GBAO Region	Country: Tajikistan
Primary cause: Inadequate training (?)	Secondary cause: Management/control inadequacy (?)
Class: Tripwire accident	Date of main report: 10/09/2010
ID original source: None	Name of source:
Organisation: [Name removed]	
Mine/device: POMZ-2M AP frag	Ground condition: dry/dusty; grass/grazing area; steep slope
Date record created:	Date last modified: 25/08/2016
No of victims: 1	No of documents: 2

Commission's Report on investigation of the mine accident on the road passes of Khaburobod Darvoz District

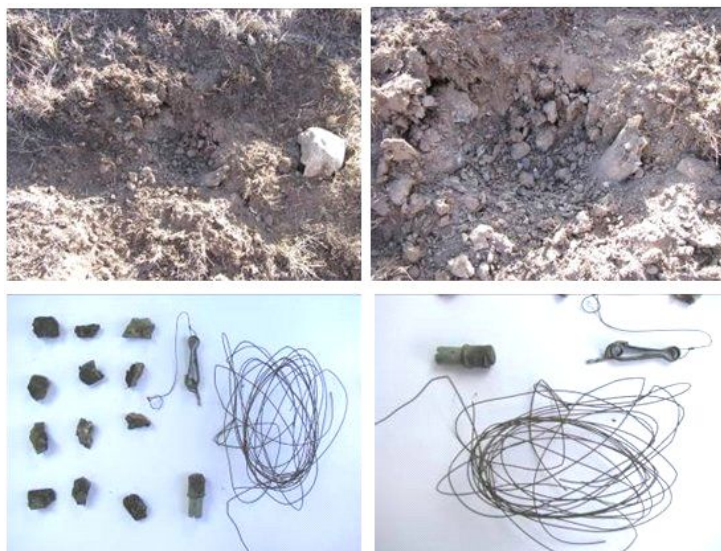
During the analysis of the place of the explosion, the remaining mine stick and excessive fragmentation found in the area provided evidence that the POMZ-2M was lying on its side. The mine was on the top of the earth. The below shows the depth of the crater.

[The crater and removed fragments are shown above.]

This anti-personnel fragmentation mine exploded on the surface of the earth. Its stick had rolled on the ground and the mine fell on one side. The area where the mine detonated had not been cleared. It was 6 m away from the right side on the cleared passage in which the replacement of the marking sticks was occurring when the explosion happened.

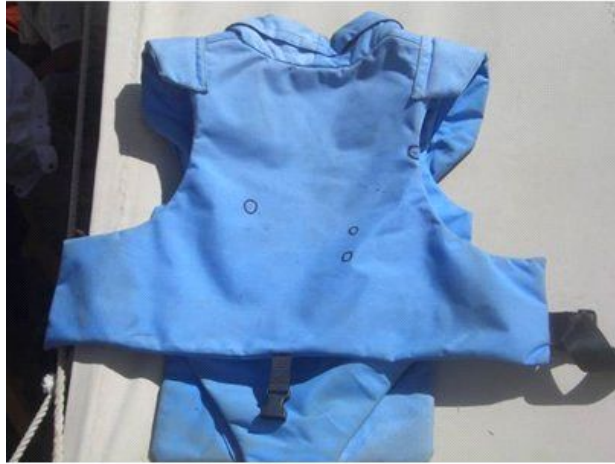
The injured de-miner had all the required PPE. After the investigation of the injured de-miner PPE it was found that during the explosion 4 fragments struck his back but did not make any negative impact. [The armour had a poly-aramid back with appears to have no Kevlar insert: this was marked but not holed, see below.]

The back of the body armour used by the deminer prevented him from the getting more wounds in his back. Most likely, if the deminer used only the front part of the armour, the deminer may have received serious injuries in his body.
