# DDASaccident812

# DDAS Accident Report

<b>Report date:</b> 25/08/2016	<b>Accident number:</b> 812
<b>Accident time:</b> 10:45	<b>Accident Date:</b> 17/05/2016
<b>Where it occurred:</b> Risk Area 12, Tal Al-Rabiea Village, Daquq, Kirkuk Governorate	<b>Country:</b> Iraq
<b>Primary cause:</b> Other (?)	<b>Secondary cause:</b> Management/control inadequacy (?)
<b>Class:</b> Handling accident	<b>Date of main report:</b> Not recorded
<b>ID original source:</b>	<b>Name of source:</b> Iraqi Kurdistan Mine Action Agency
<b>Organisation:</b> FSD	
<b>Mine/device:</b> IED	<b>Ground condition:</b> dry/dusty; hard
<b>Date record created:</b>	<b>Date last modified:</b> 25/08/2016
<b>No of victims:</b> 1	<b>No of documents:</b> 2

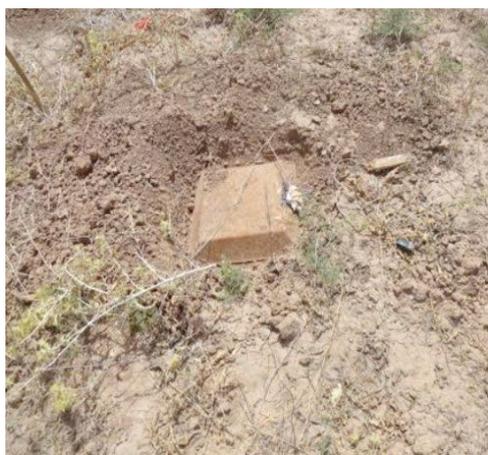
The first IED was defused by [the Victim].

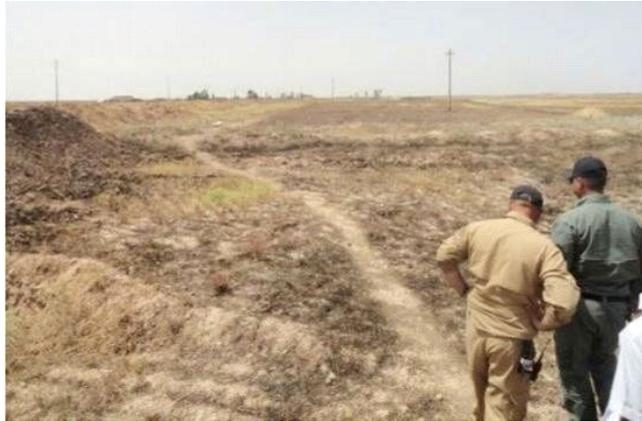
The nature of the land in this risk area is a large plain and leveled with existence of an earthy screen. Type of the land is hard and because the worksite is burned, there are very few grasses in the area and the village itself is totally destroyed.

[Picture showing hard, dry ground with little vegetation.]

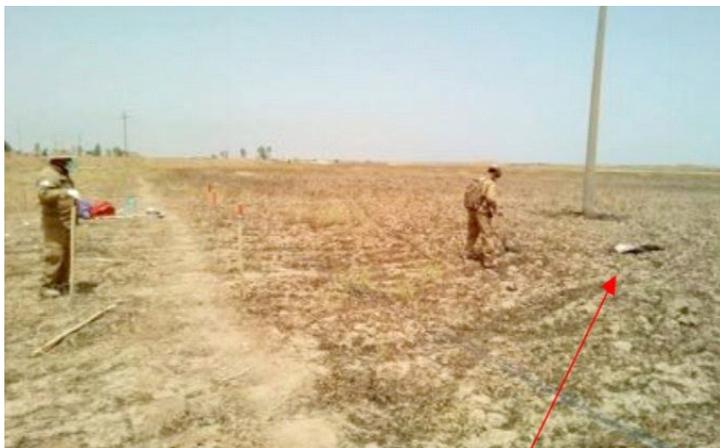
Access lines to the body

Because the affected person has died at once and his body fragmented into pieces the process of accident response was not implemented and only fleshes from his body and part of his body were discovered and collected and his right leg was fallen in the risk area and by opening lines the operation team could get it out to safer areas and handed to the police department in Daquq and from there to the Morgue in Kirkuk, a day after was sent to Erbil and on 29/05/2016 the body was sent back to Australia.

Part of [the Victim's body is fallen in the risk areas and one of the operators is trying to get it out.

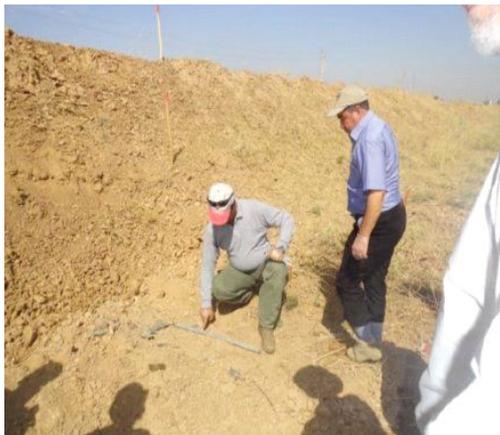
BOI Members at the location of the explosion

At the same date of the accident, QA team is there to gain the prime evidences.
