DDASAccident127

DDAS Accident Report

Report date: 15/05/2006	Accident number: 127
Accident time: not recorded	Accident Date: 19/03/1998
Where it occurred: Shoorandam Village, Daman District, Kandahar Province	Country: Afghanistan
Primary cause: Field control inadequacy (?)	Secondary cause: Inadequate training (?)
Class: Excavation accident	Date of main report: [No date recorded]
ID original source: none	Name of source: MAPA/UNOCHA
Organisation: Name removed	
Mine/device: PMN AP blast	Ground condition: hard
Date record created: 13/02/2004	Date last modified: 13/02/2004
No of victims: 1	No of documents: 1

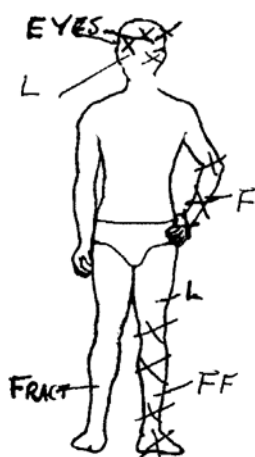
The initial field report recorded the injuries as, "injury of both eyes, multiple injuries on face; left shoulder anterior wounds; fracture of both bones, left leg; fracture of both bones, left forearm; superficial wounds on right thigh and leg". A sketch made by the field medic shows left arm, hand and leg injury, and face and eye damage.

The injuries indicate that the victim was stepping on the shovel when the initiation occurred, so allowing the energy to transfer to his leg and arm with bone breaking force. His eye and face injuries confirm that he was not wearing his visor. This was not noted by the investigators.
